Inspection Report

455 Crow Hill Dr.
Georgetown SC 29440

Buckeye Home Inspections

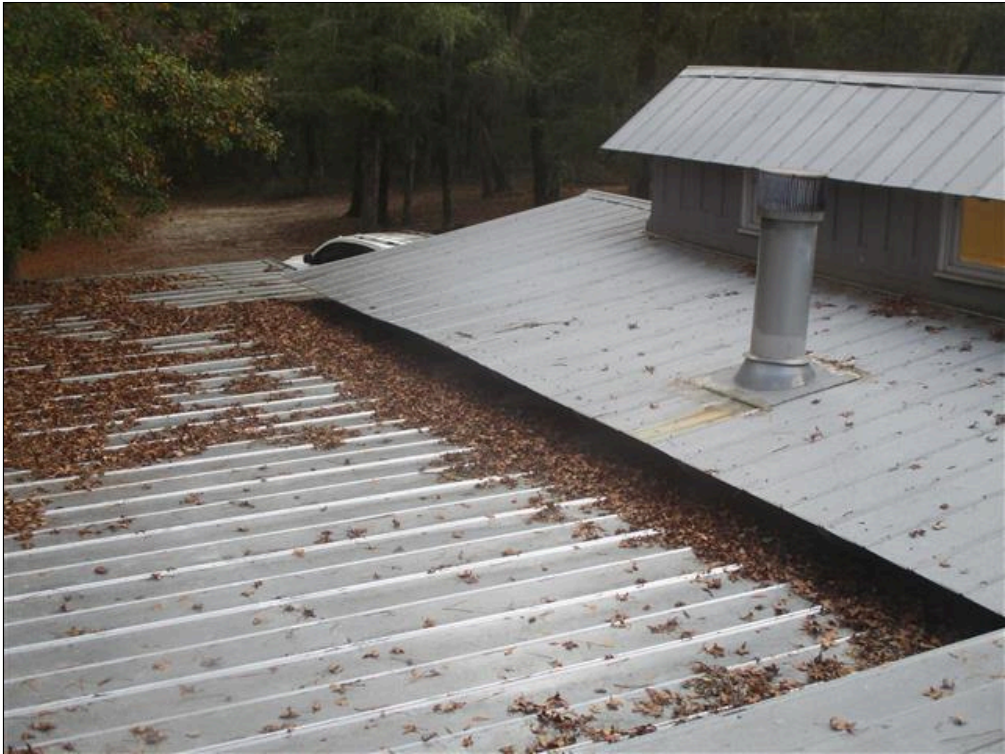
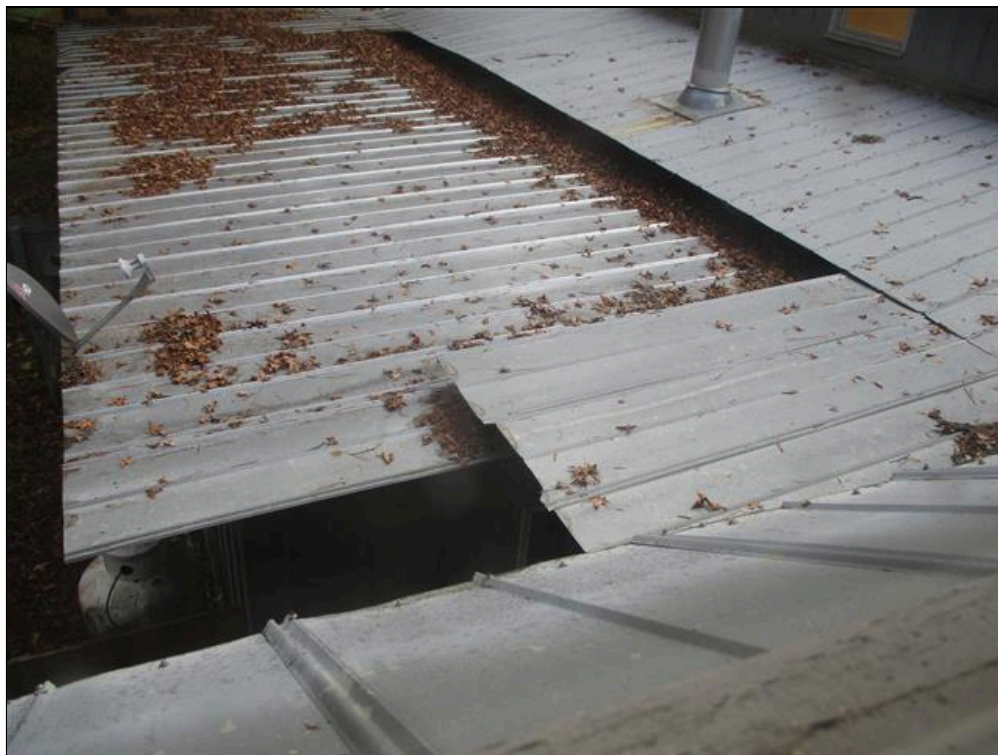
- (1) Much of the roof covering was covered with tree debris. Recommend a qualified professional remove all the debris from the roof covering.
- (2) Overall, the roof covering installation appears amateur. The roof covering was heavily rusted, there were signs of possible roof flashing issues, and there were signs of roof leaks in areas. Recommend a licensed roofing contractor inspect further and make all needed repairs.

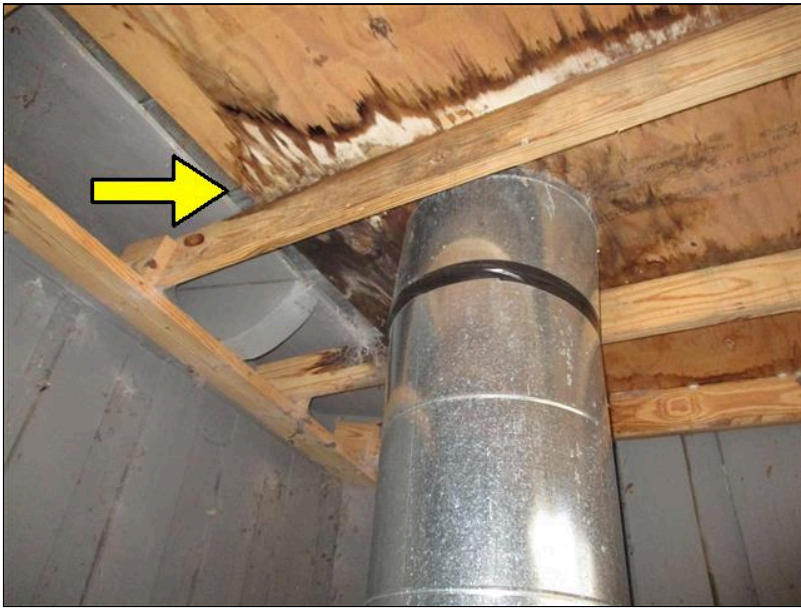
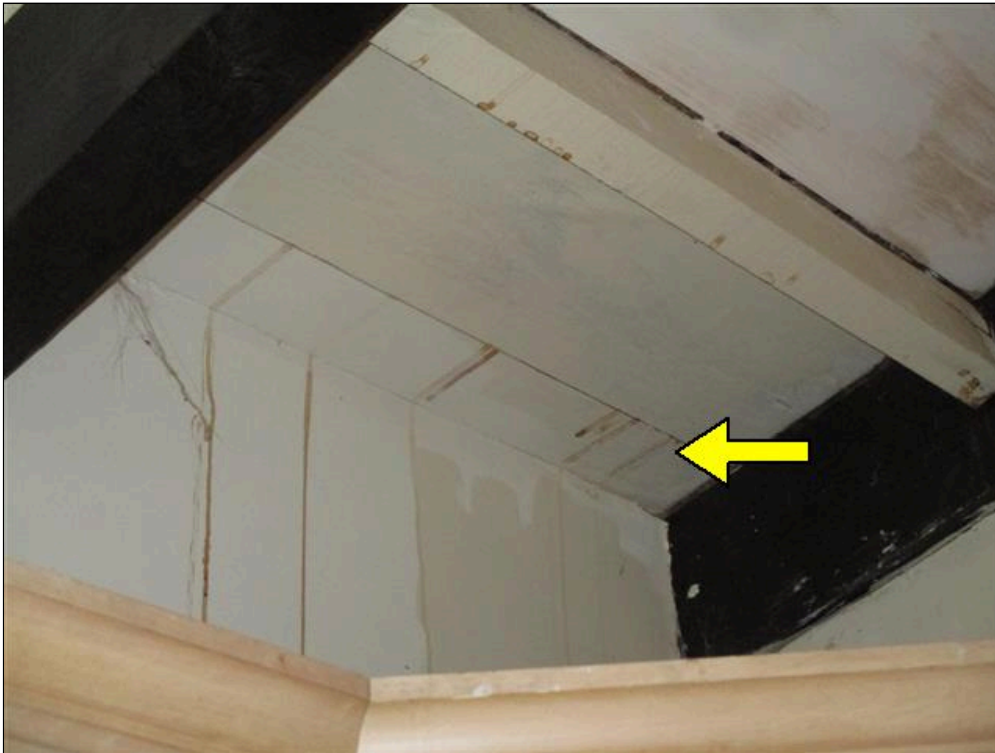
There are signs of active roof leaks above the package heat pump and in the kitchen. Recommend a licensed roofing contractor inspect the roof further and make needed repairs or replacements.

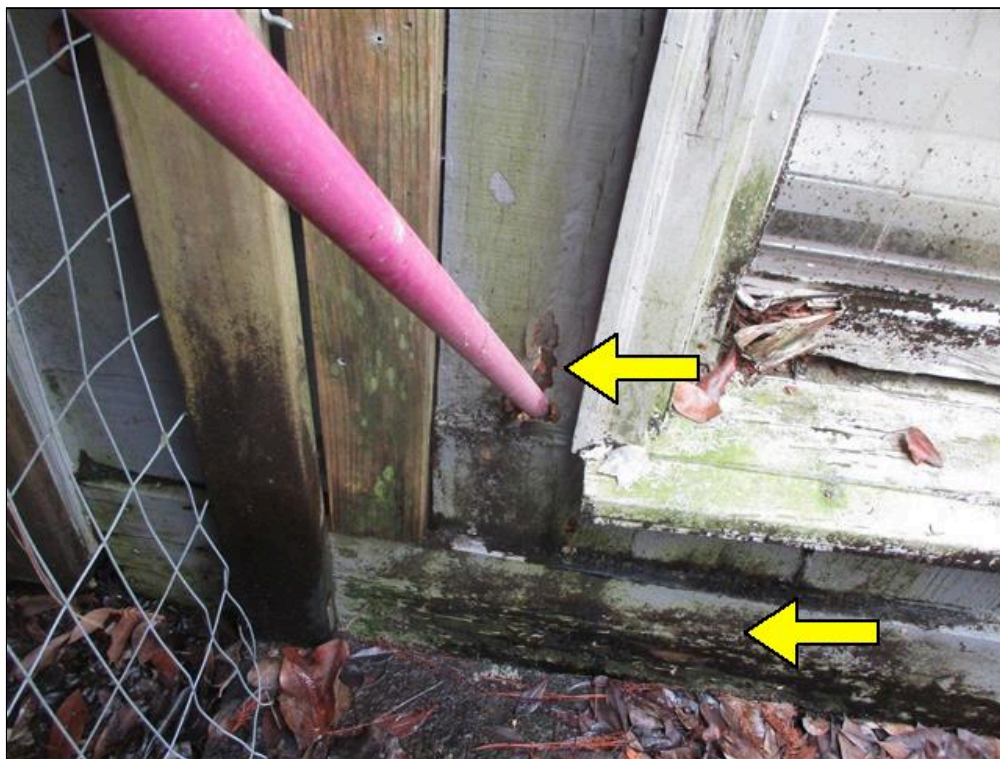
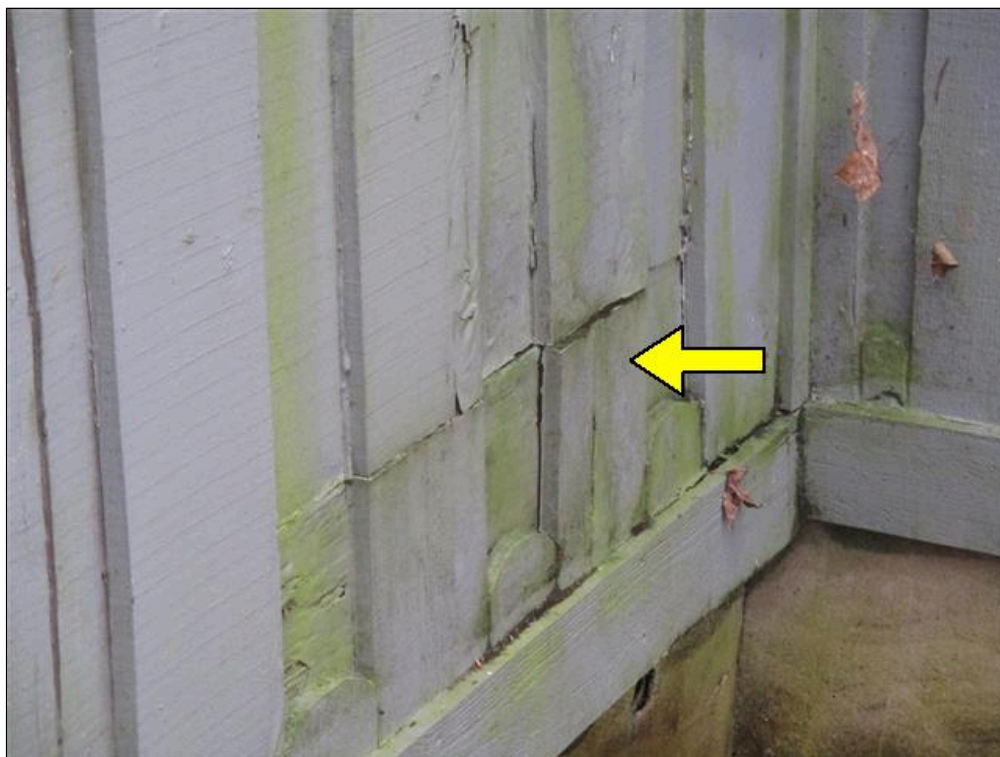
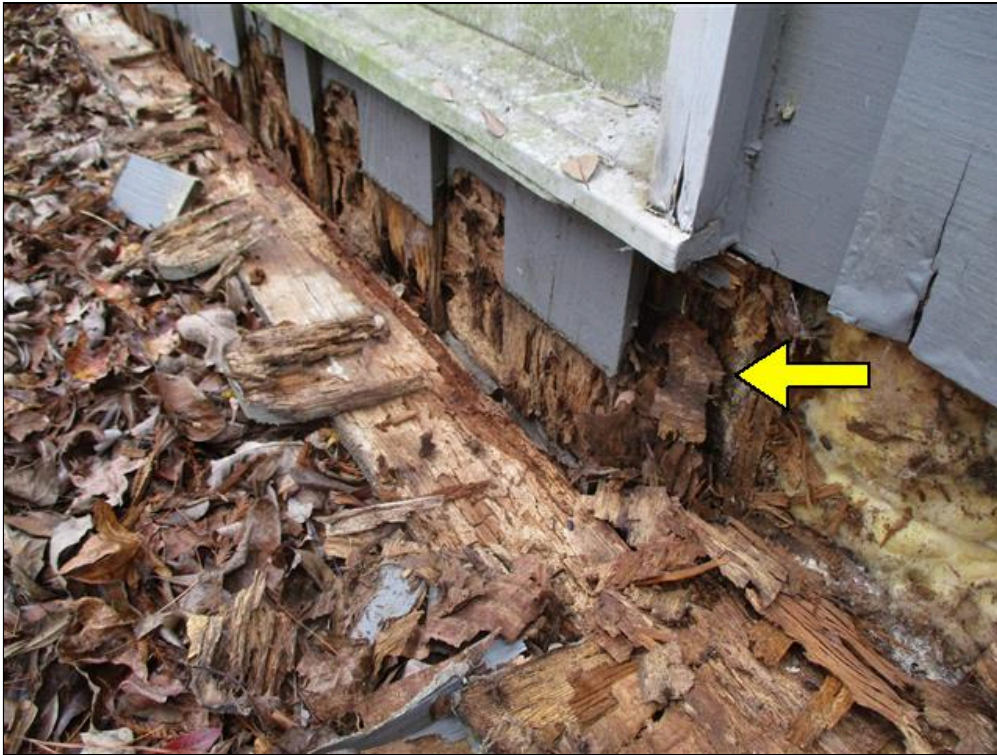
(1) The siding is in overall poor condition around the dining room area of home. There were multiple signs of failure, wood rot, and wood destroying pest damage. Further damage, including wood rot, framing damage, water intrusion, and increased pest damage will occur if not repaired. Recommend a licensed contractor inspect further and make all needed repairs.

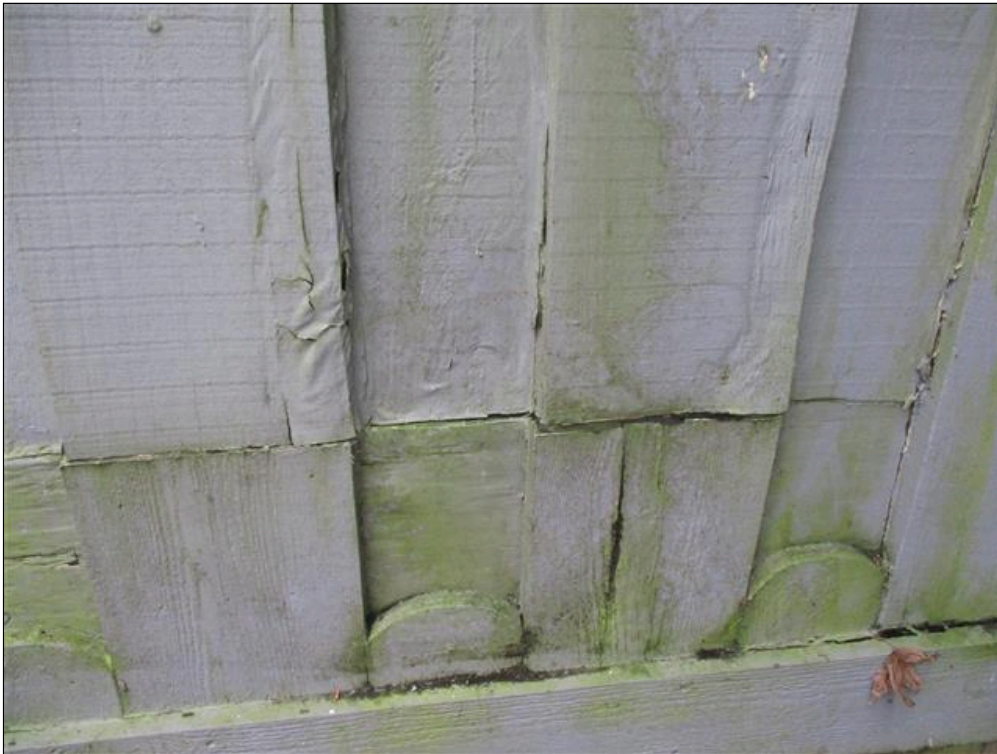
(3) Much of the wood siding is deteriorated around the perimeter of home (bottom 1-2 feet) at front, rear, and sides of home. Further damage will occur if not repaired. Recommend a qualified contractor make all needed repairs or replacements.

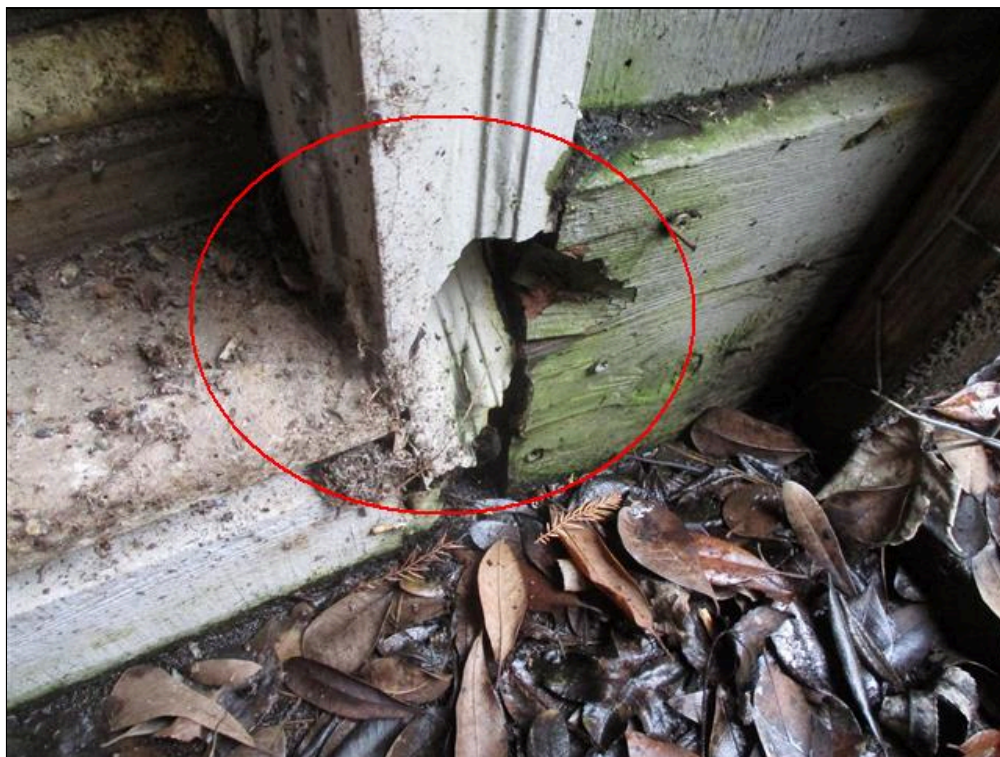
repaired. Recommend a licensed contractor inspect further and make all needed repairs.

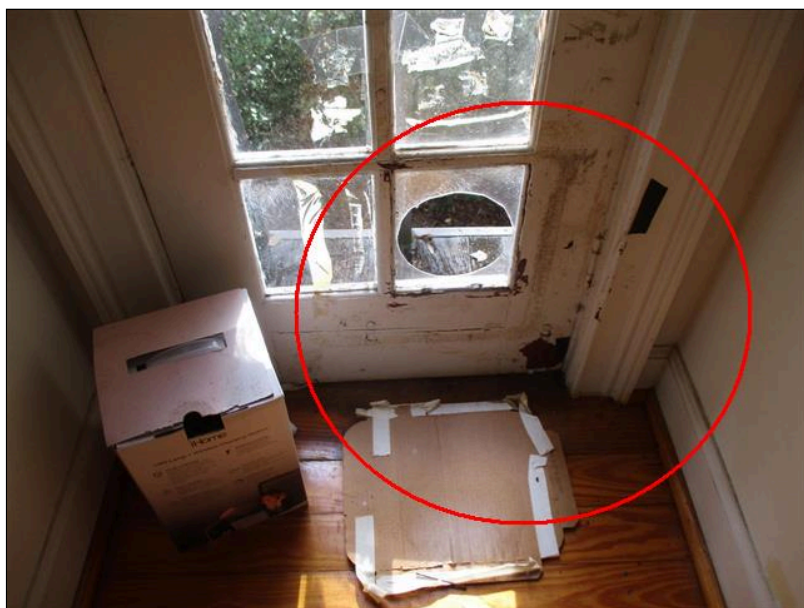
(3) The exterior door at the upstairs bedroom is in overall poor condition. There are holes in the door and there are signs of moisture intrusion. The door needs replaced.

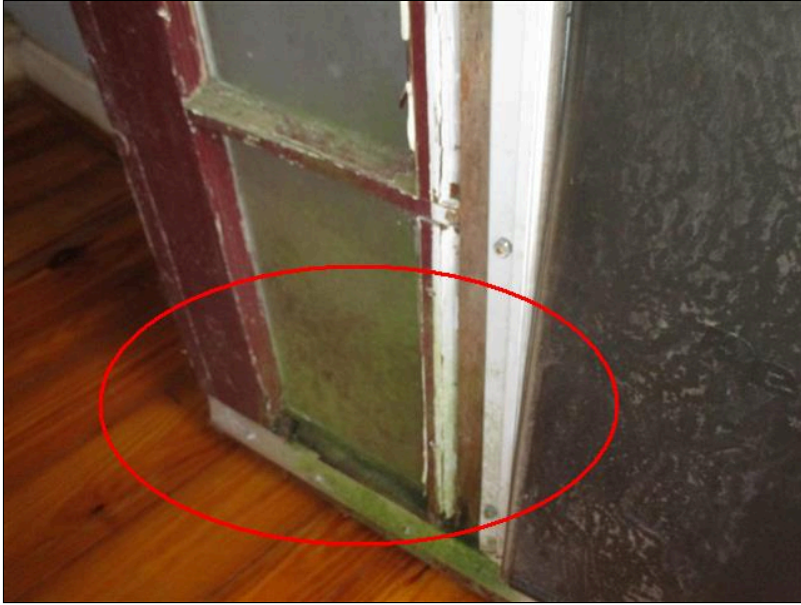
- 🏠 (4) The exterior door leading to the dining room (at rear of home) revealed multiple signs of wood rot and moisture intrusion. Further damage will occur if not repaired. Recommend a licensed contractor make all needed repairs.

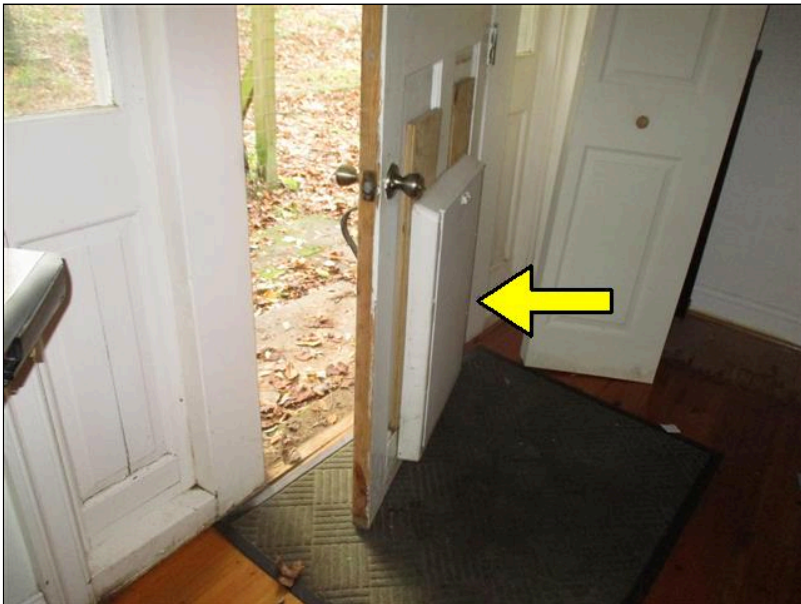
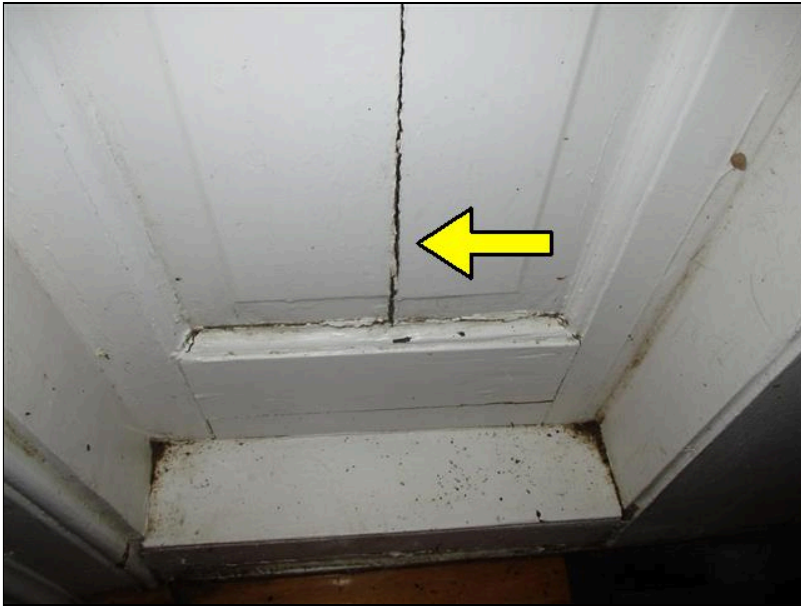
- 🏠 (5) The exterior door at the master bedroom revealed the following defects:
- there was a large pet door installed
 - there were multiple cracks in the wood door (door core and sides of door)
 - there were signs of moisture intrusion

Recommend a qualified contractor make all needed repairs and/or replacements.

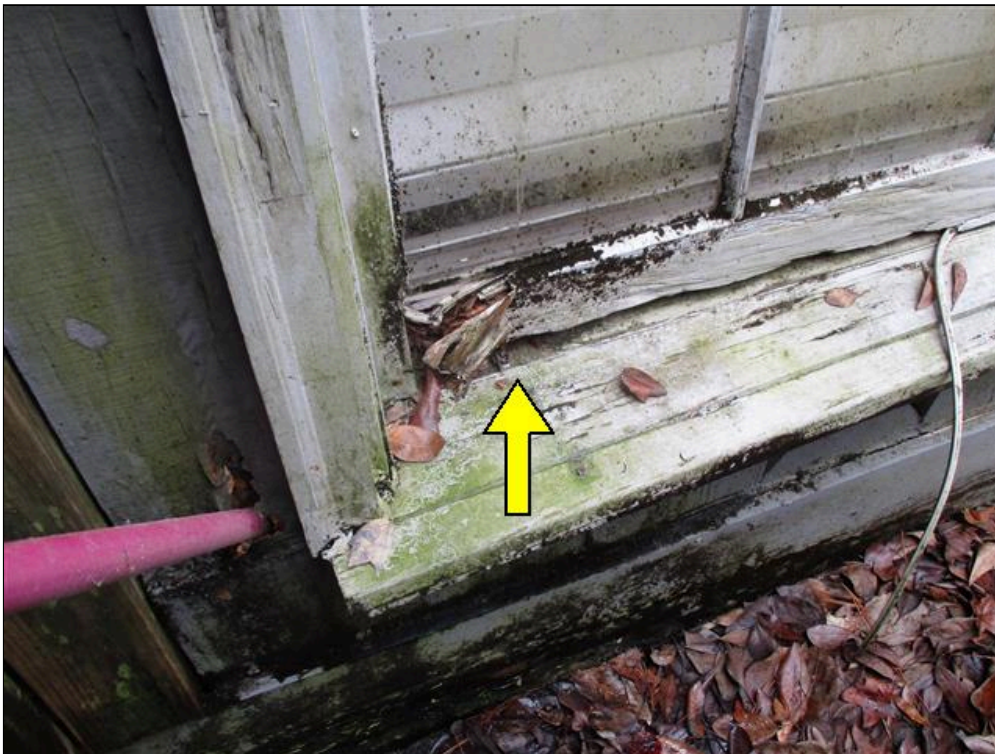
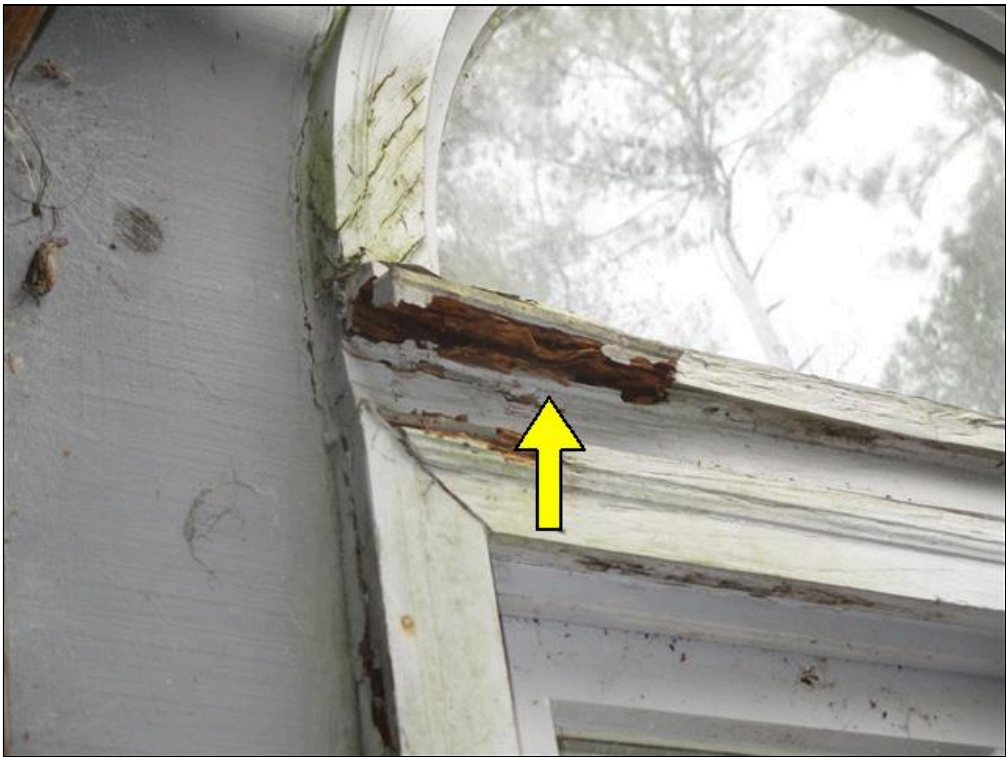
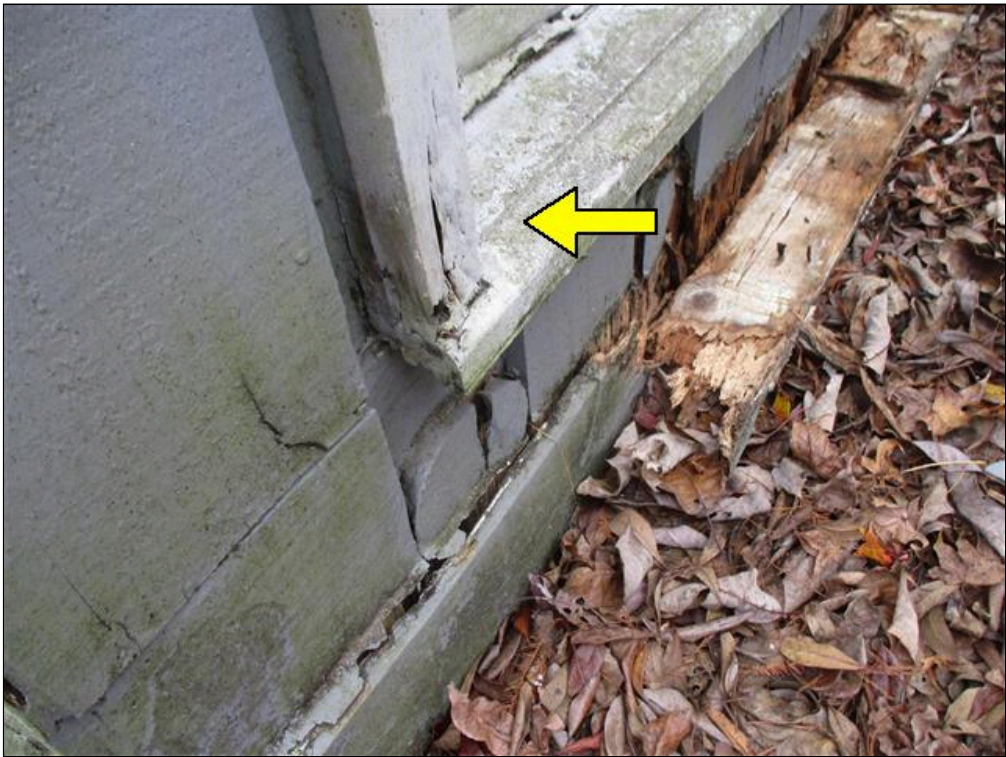
(1) All of the windows at the dining room area of home were deteriorated and in poor condition. It appeared as though all the windows in the dining area were failing and need replaced. Further damage, including wood rot, water intrusion, and pest damage will occur if not repaired. Recommend a licensed contractor inspect further and make all needed repairs.

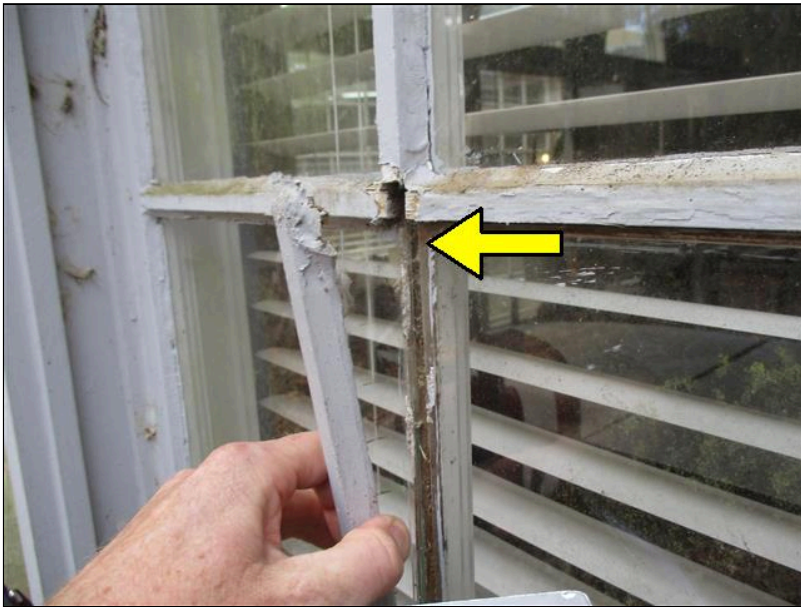
- 🏠 (2) The windows appear to be aged single pane glass windows. Why? Typically, homes built in the 90's had thermal insulated or dual pane glass windows.
- 🏠 (3) Most if not all the windows are aged and reveal wood rot and moisture damage in areas. Recommend a licensed contractor make all needed repairs and/or replacements.

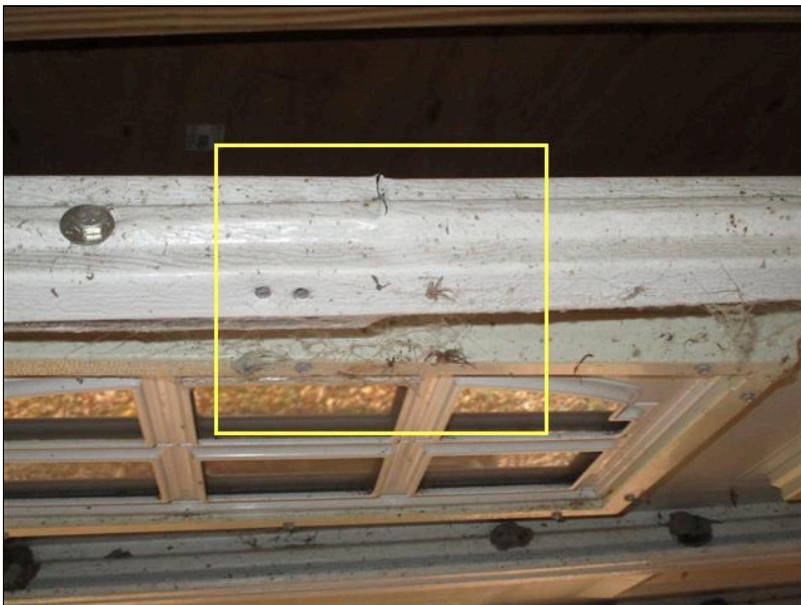
- 🏠 The following defects were visible with the garage door at time of inspection:
- the door was sagging and weak
 - the door was split at the top middle of door
 - the door was misaligned or crooked

The garage door is not safe to use in its current condition. Recommend a qualified contractor make all needed repairs.

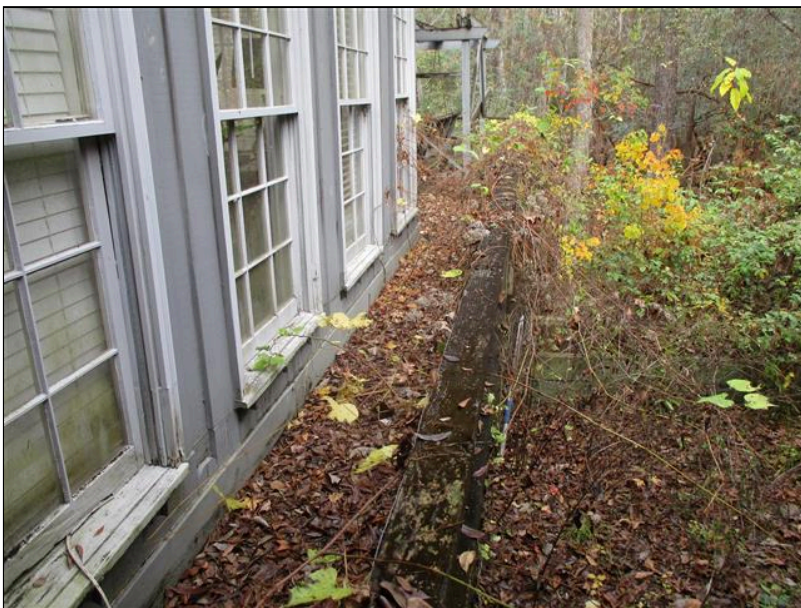
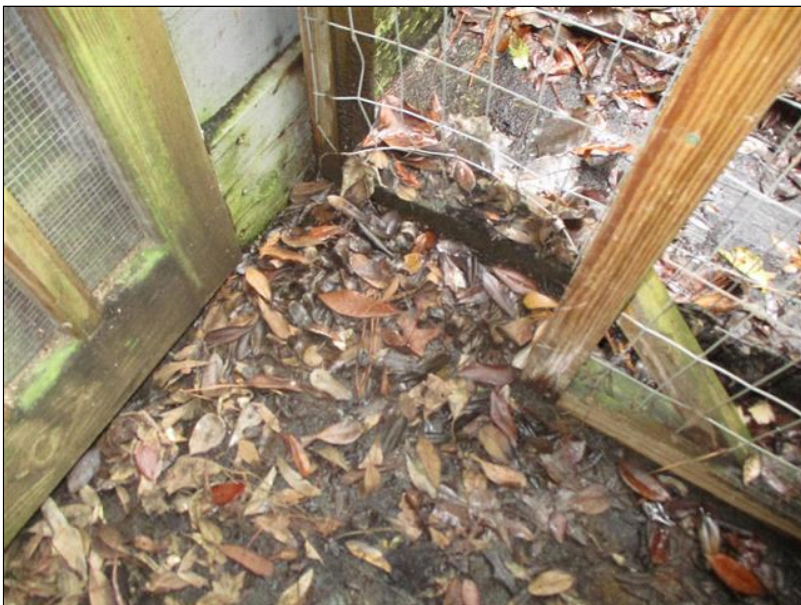
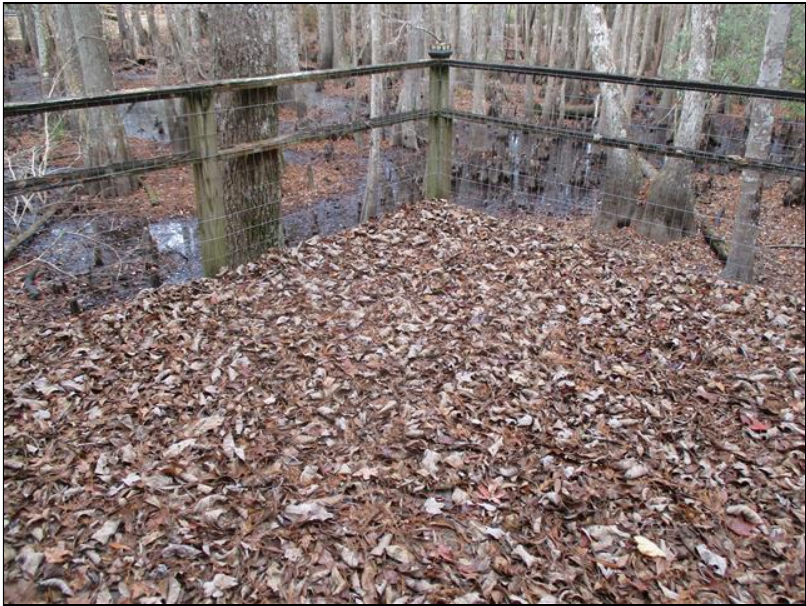
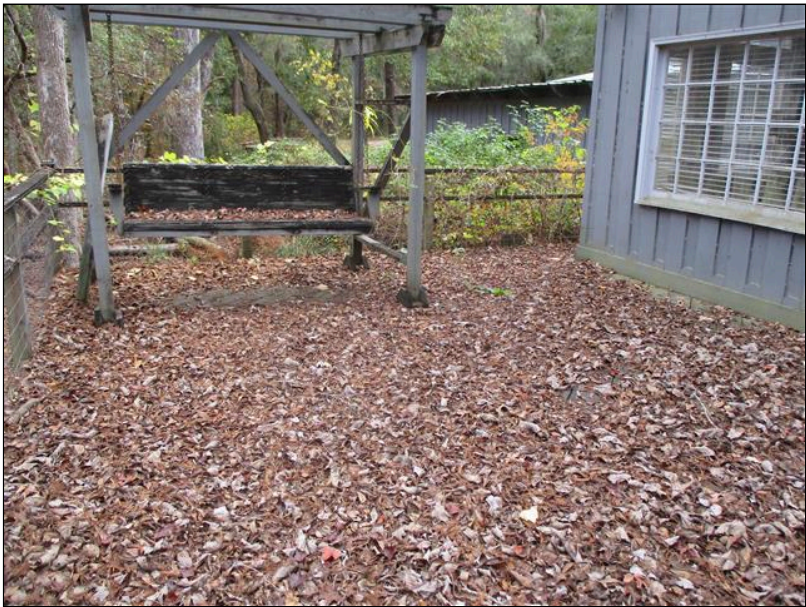
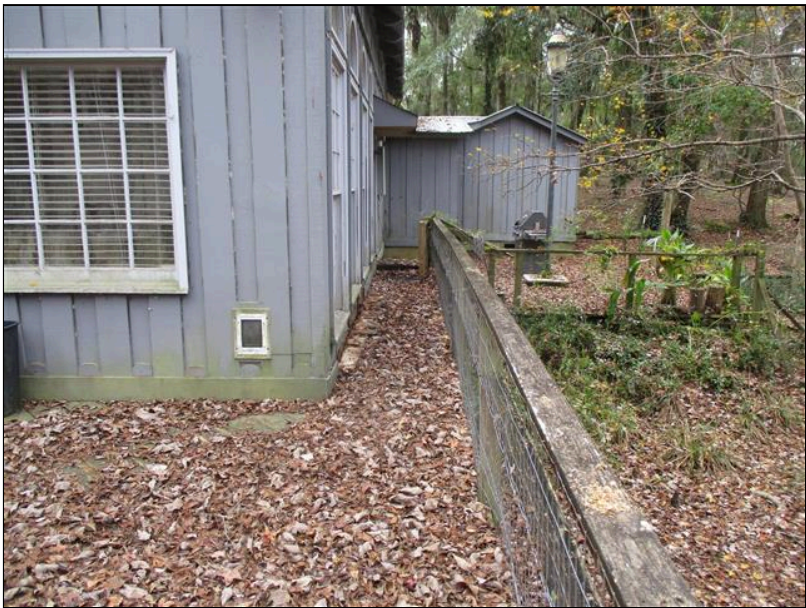
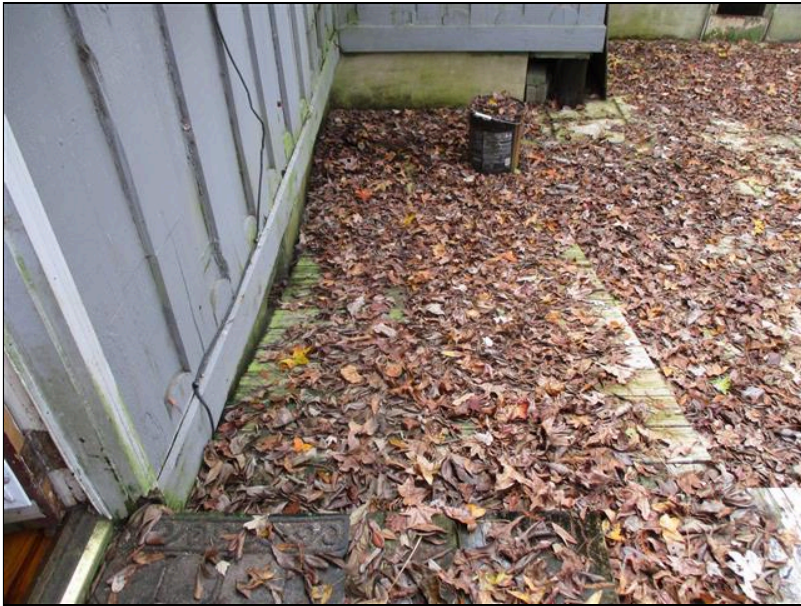
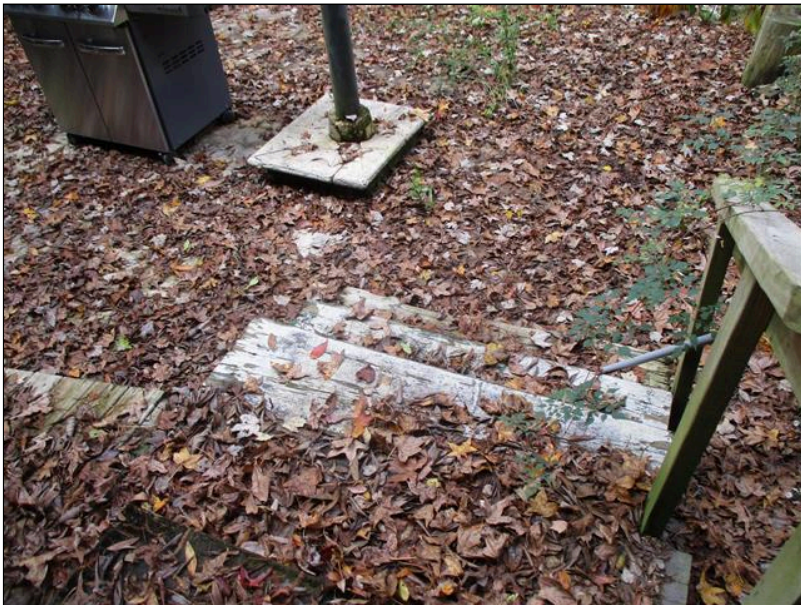
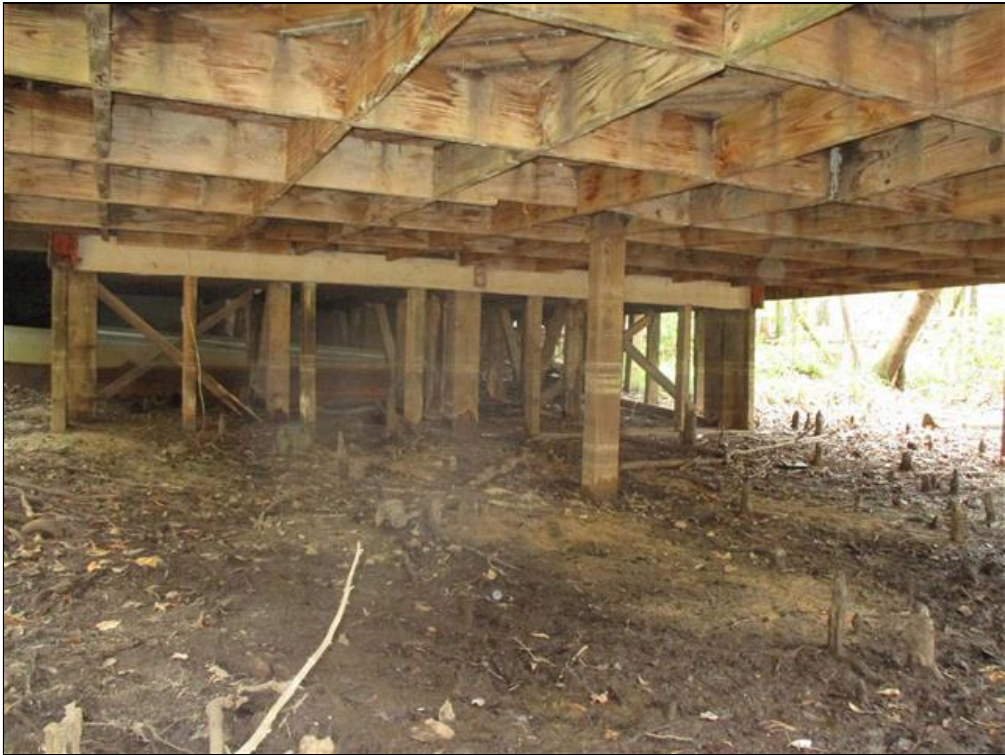
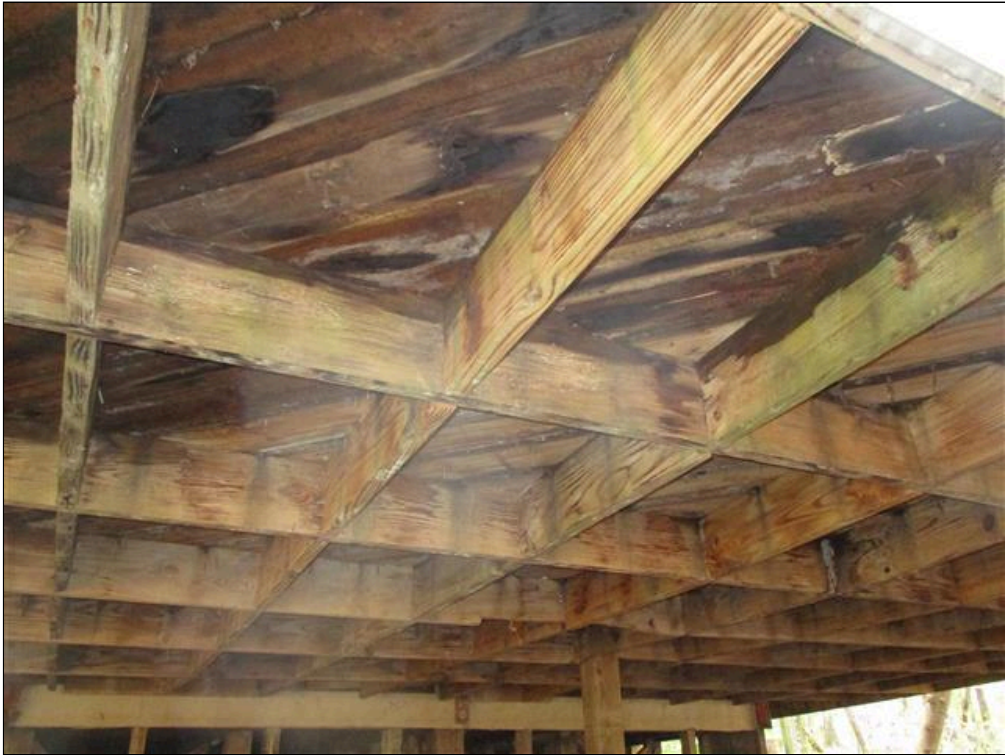
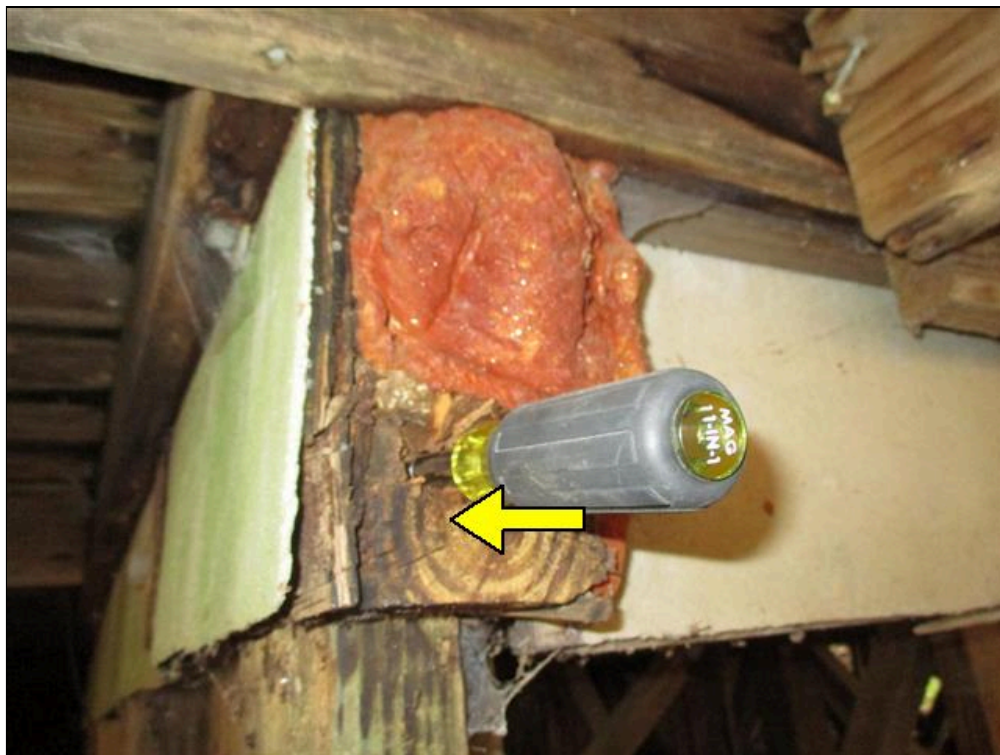
(1) The following defects were visible at the deck at rear and sides of home at time of inspection:
- there is heavy moss/algae growth in areas
 - the decking boards are unlevel leaving tripping hazards
 - there are multiple signs of moisture damage/wood rot to the structure under the deck
 - multiple decking boards were heavily weathered and beginning to fail
 - much of the deck was covered by tree debris and not visible
 - the steps were unlevel and deteriorated in areas
 - there is no handrail at the ramp

Recommend a licensed contractor make all needed repairs and replacements.

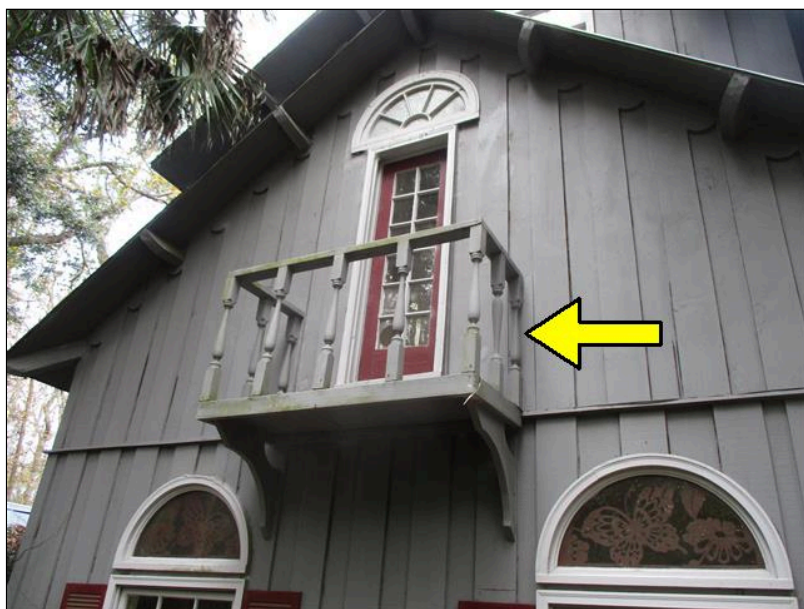
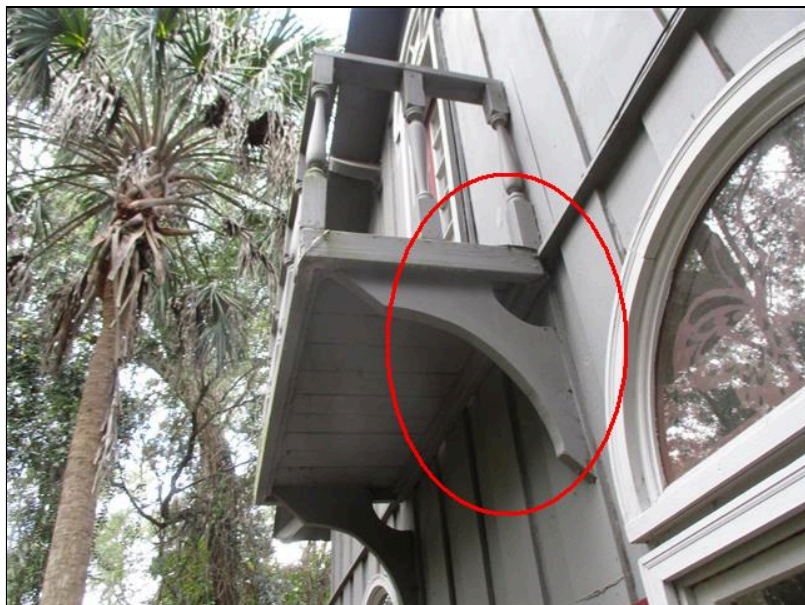
- 🏠 (2) The balcony at the upstairs bedroom is weak and failing. The pickets were missing in areas or were too wide, and the overall structure was weak and appeared to be pulling away from the home. Further damage, including failure, could occur if not repaired. Recommend a qualified professional make needed repairs and replacements.

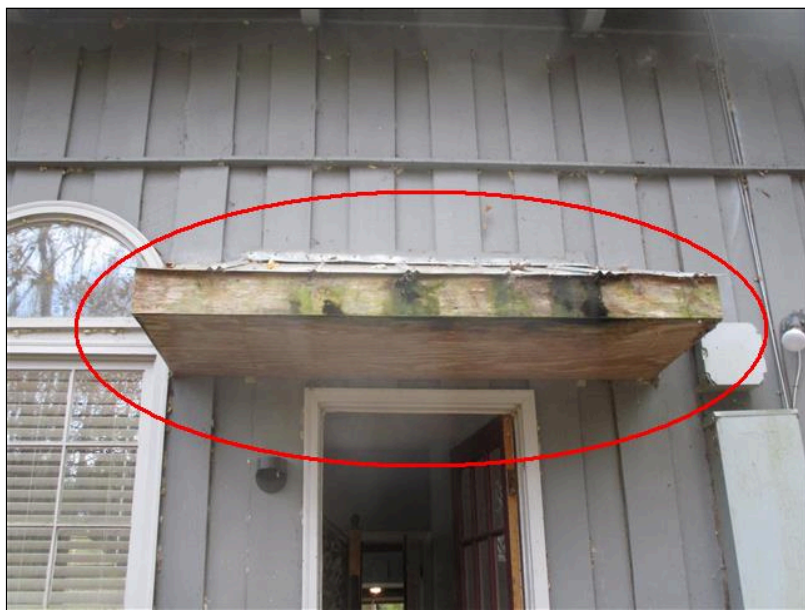
(3) The porch overhang at the left rear of home appeared to be in overall poor condition. There were signs of wood rot and failure in areas. Recommend a qualified contractor inspect further and make all needed repairs or replacements.

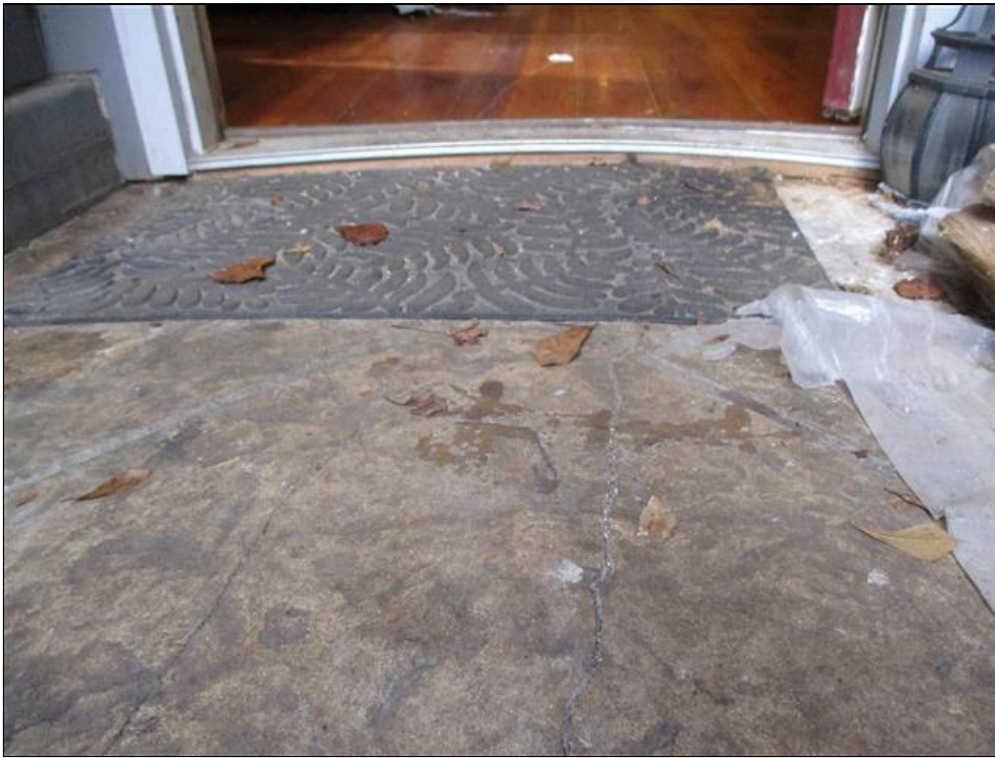
- 🏠 (4) The floor at the front porch is unlevel. It's high in the middle and sags at the sides. This negatively affects the door as well. Recommend a qualified professional make needed repairs.

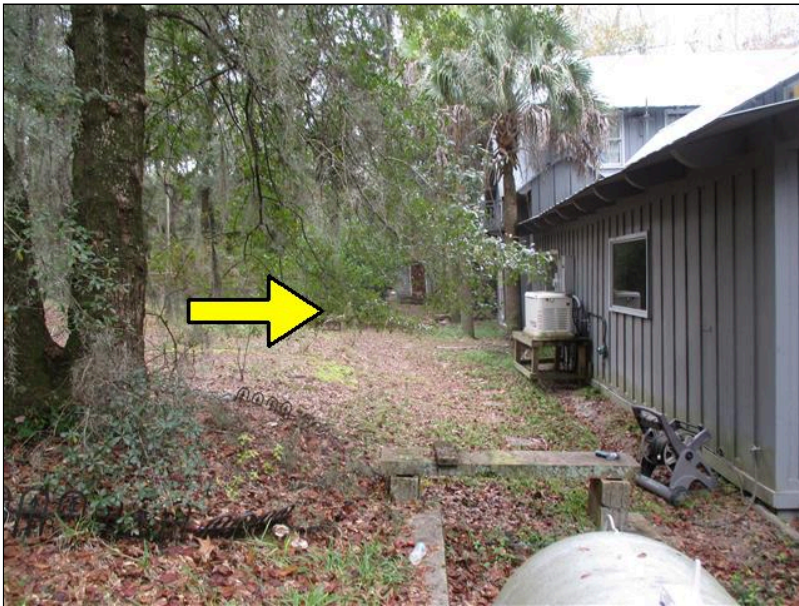
- 🏠 (1) There is a negative slope towards left side of house (facing front). This area does not appear to drain water away from home and needs landscaping and drainage corrected. Further damage, including water intrusion and wood rot could occur if not repaired.

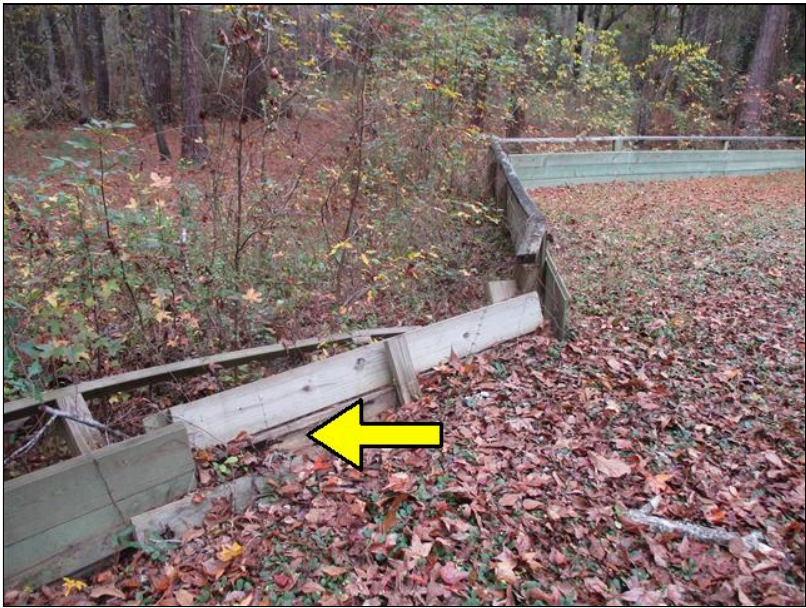
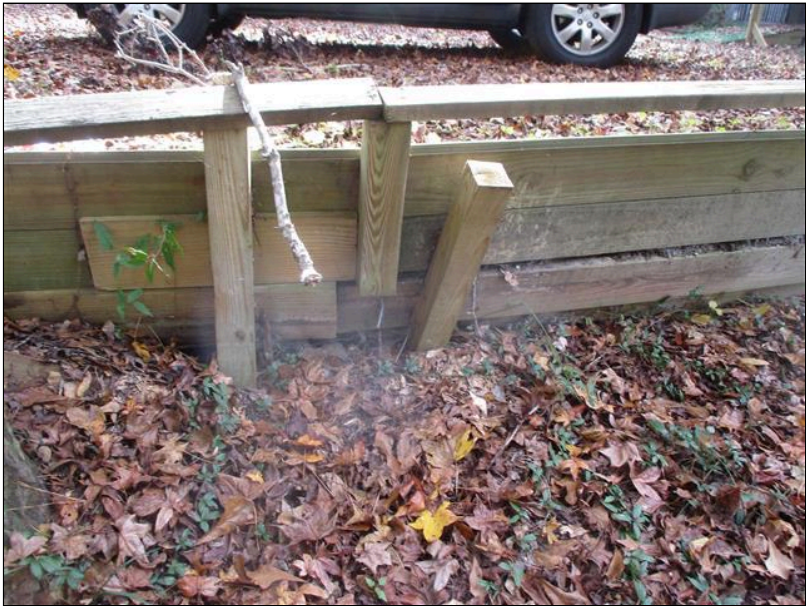
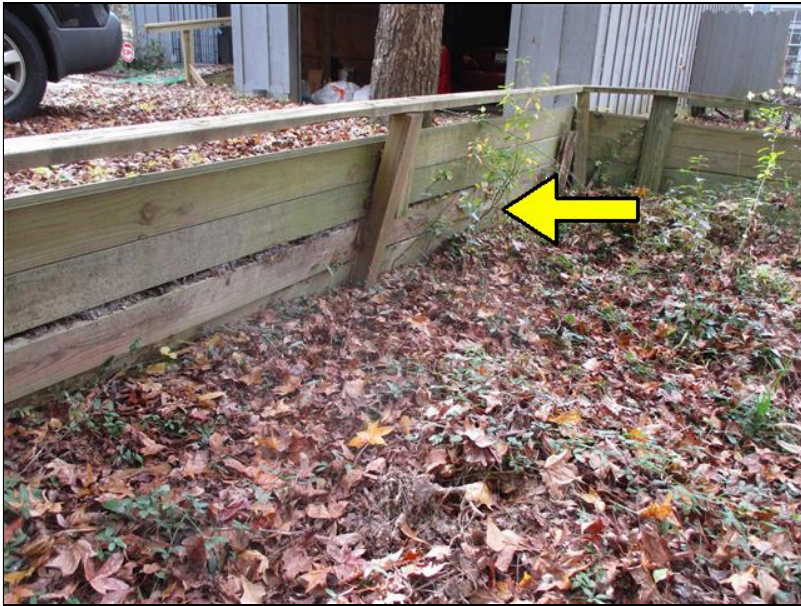
- 🏠 (3) The retaining wall at the right side of driveway reveal multiple signs of failure. It appears the retaining wall has collapsed. Further damage will occur if not repaired. Recommend a qualified professional make all

needed repairs.
