Inspection Report

455 Crow Hill Dr.
Georgetown SC 29440

Buckeye Home Inspections

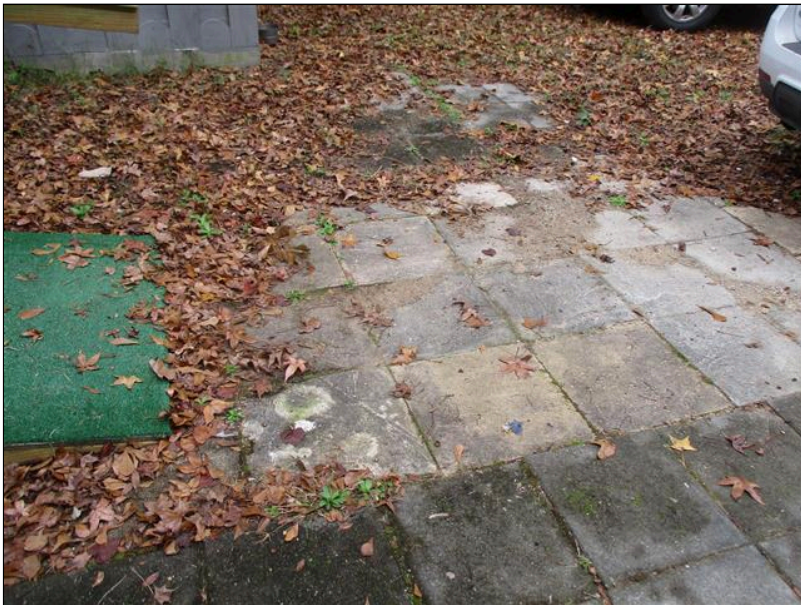
(4) The landscape walkway at front of home is unlevel leaving multiple tripping hazards. Recommend repair.

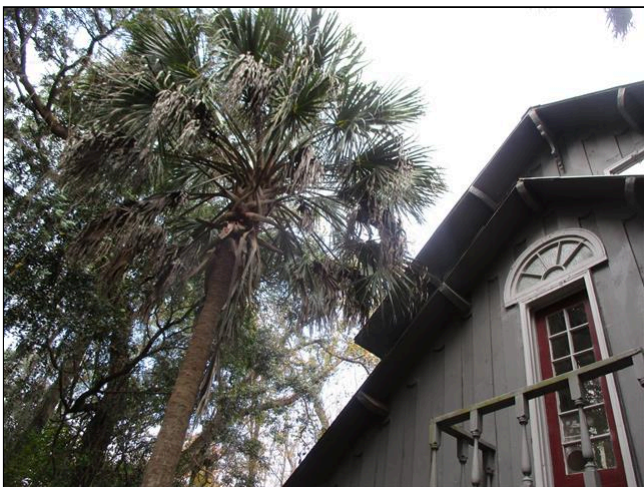
- (5) Tree limbs that are in contact with roof or hanging near roof should be trimmed.

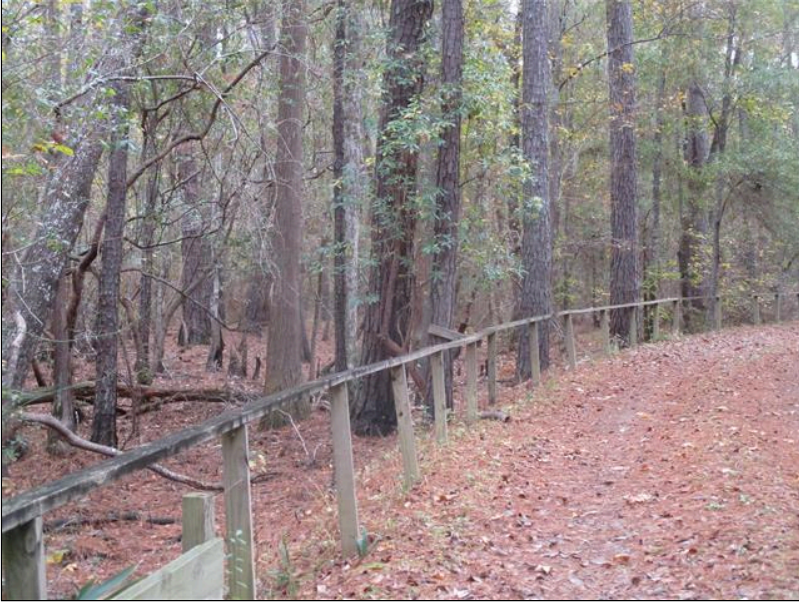
The fence at the driveway, leading up to the home, is in overall poor condition and needs replaced.

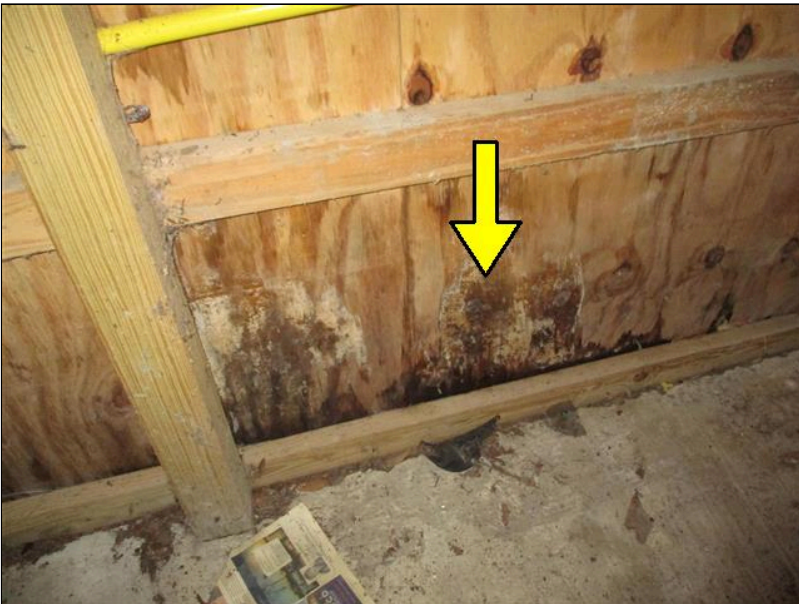
(1) There are multiple signs of active water intrusion in the garage. (Visible from the moisture stains on the wall sheathing). Recommend a qualified contractor make needed repairs.

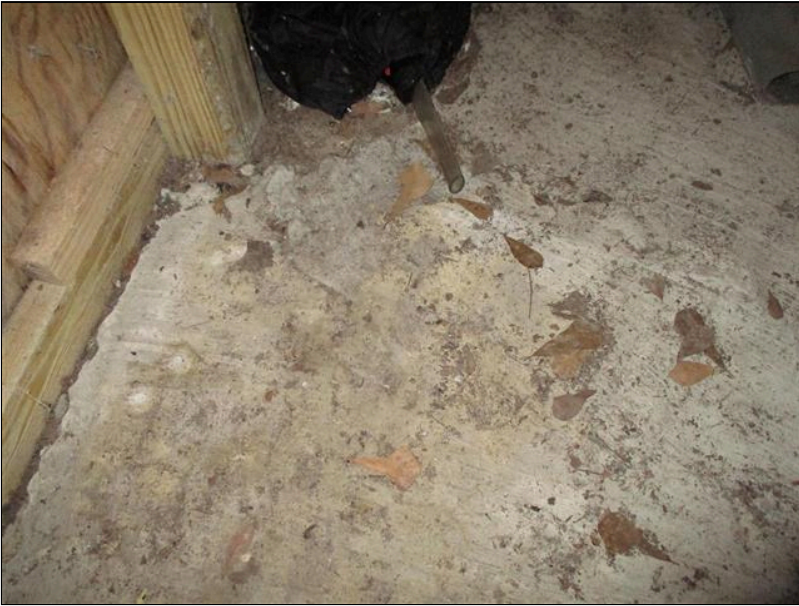
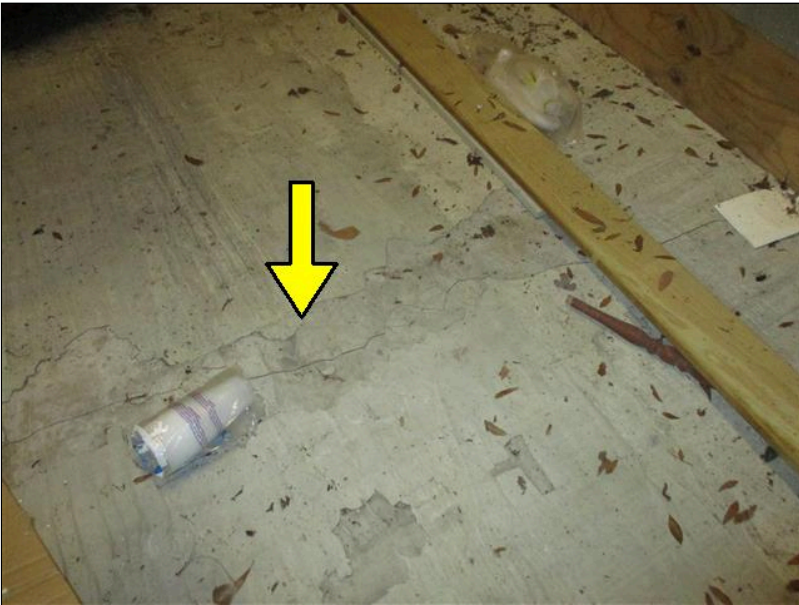
(2) The concrete inside the garage is heavily cracked and unlevel. The overall quality of work for the concrete appears amateur. Recommend a qualified contractor make all needed repairs.

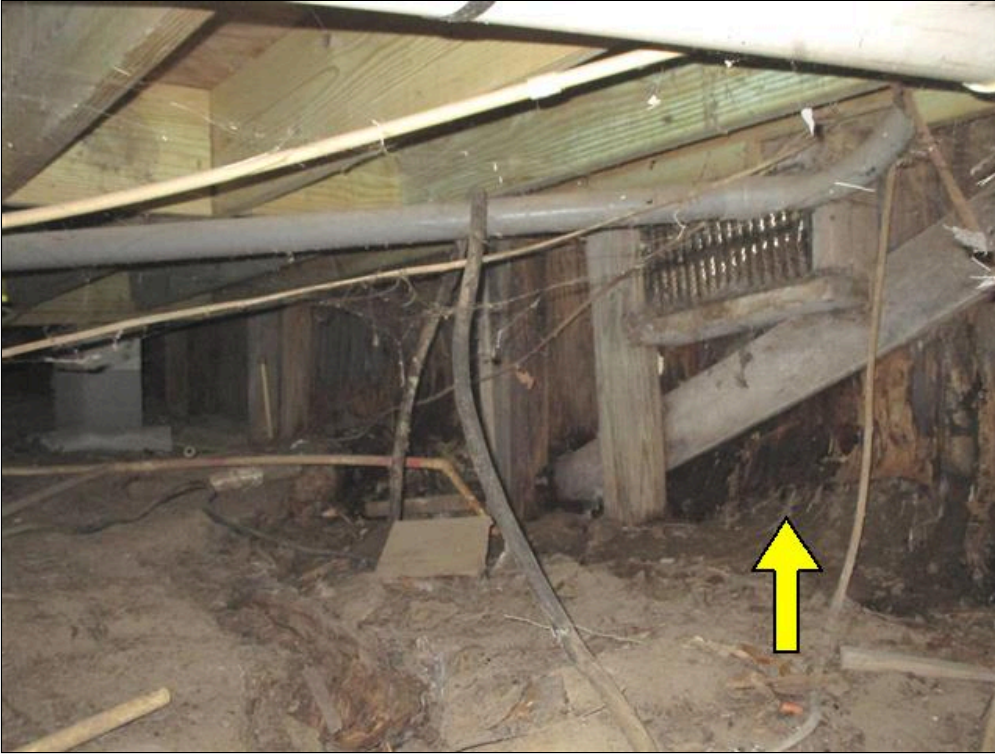
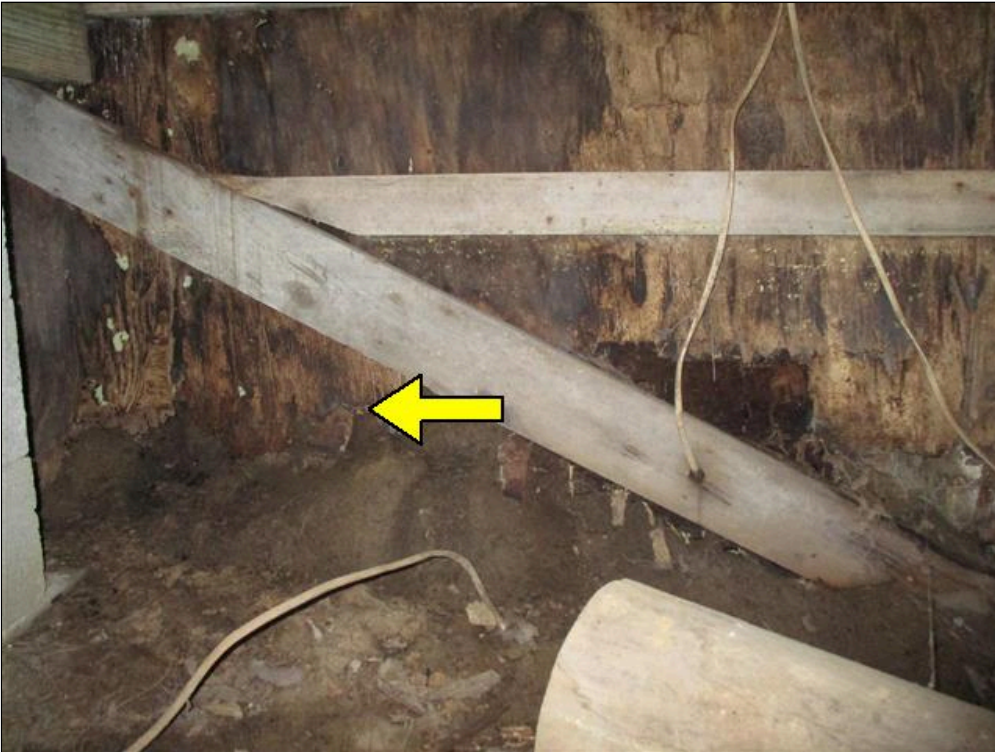
There are visible signs of active water intrusion in the accessible areas of the crawlspace. Water intrusion can cause deterioration and excessive moisture on building components if not corrected. Recommend further investigation or correction by a qualified licensed contractor.

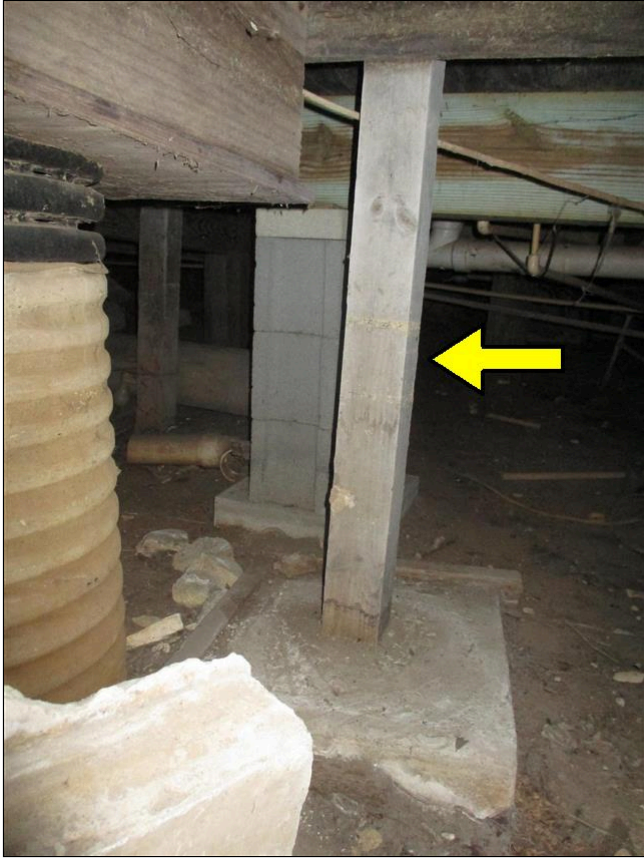
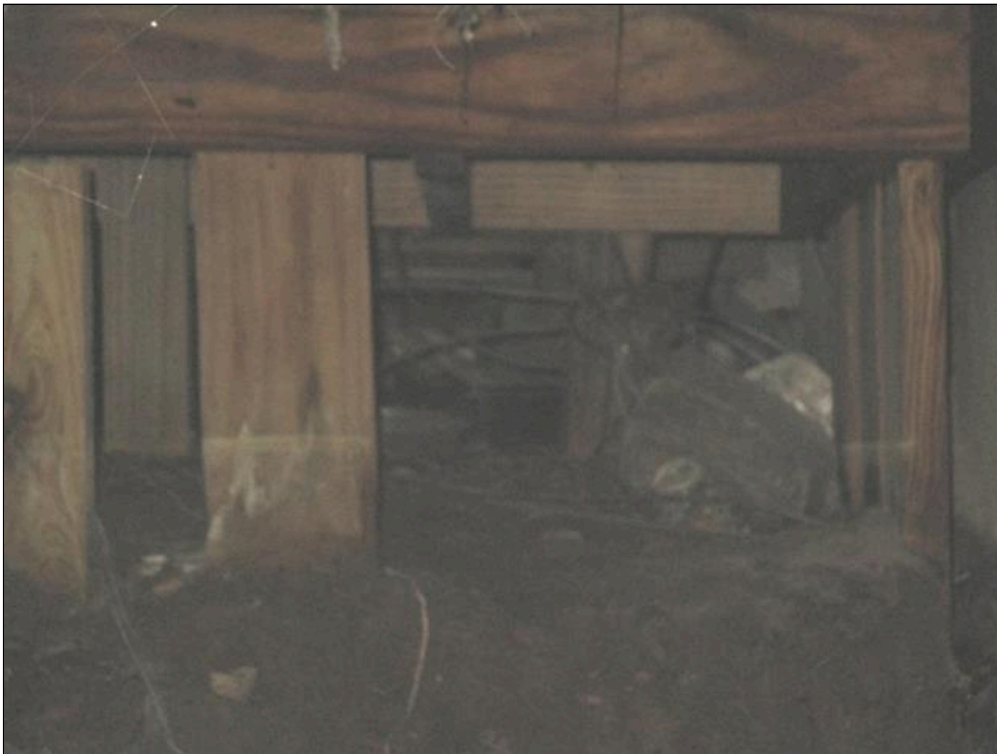
(1) The visible piers under the rear of home appears unlevel and weak in areas. The added piers were unlevel. The footings under some of the piers have failed in the visible areas. Recommend a qualified structural engineer evaluate further and make all further recommendations and repairs.

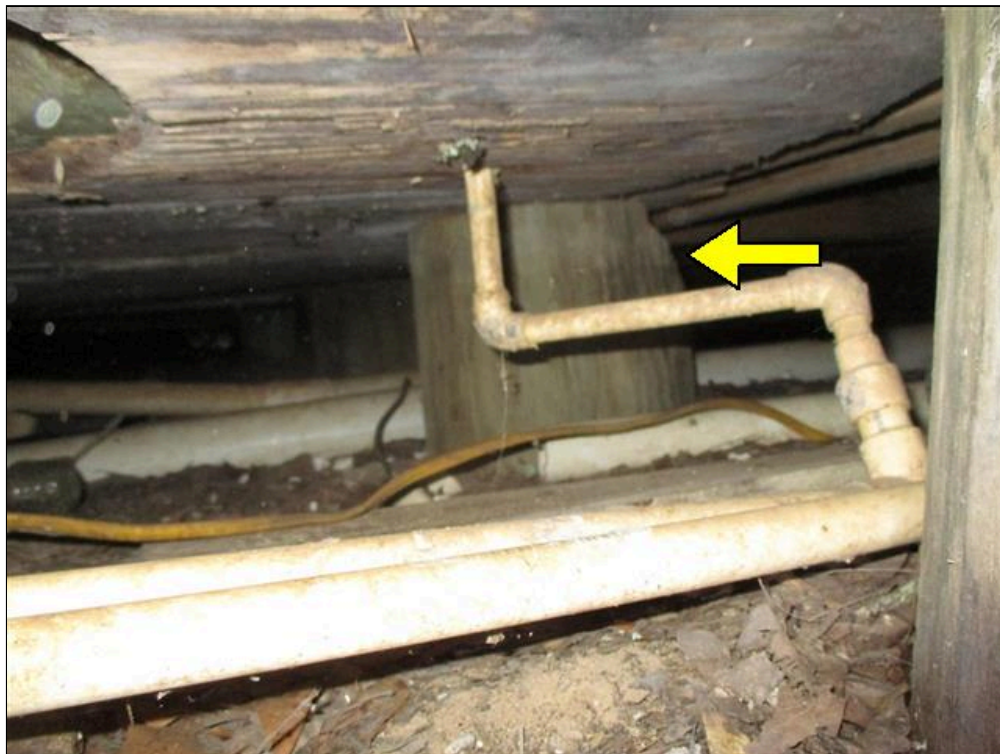
(2) Most if not all the visible piers under the home were unlevel or leaning at time of inspection. This will cause further issues to the home if not repaired. Recommend a structural engineer evaluate the home further and make all further recommendations and repairs.

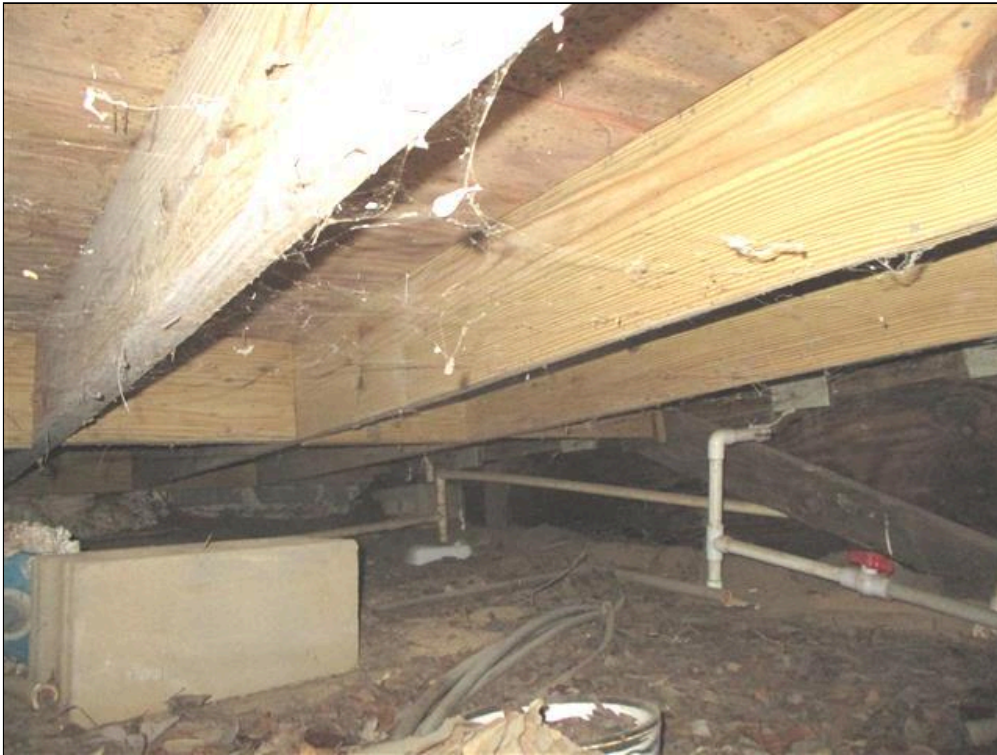
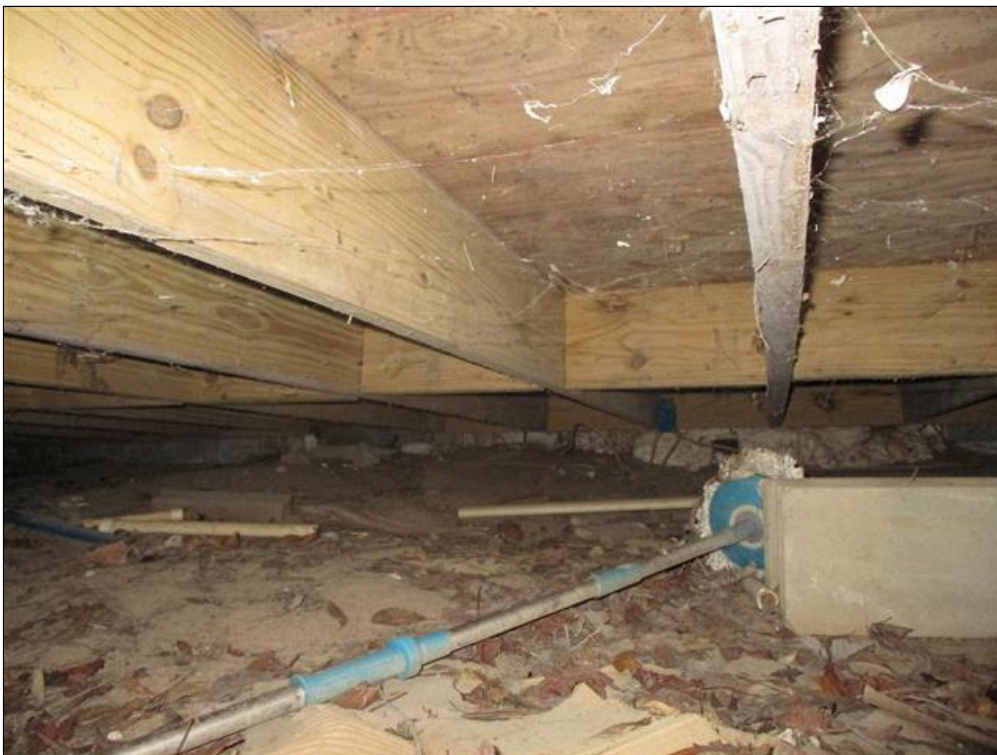
(2) The floors appear to be improperly supported in areas. Additional piers may be needed to maintain structural integrity.

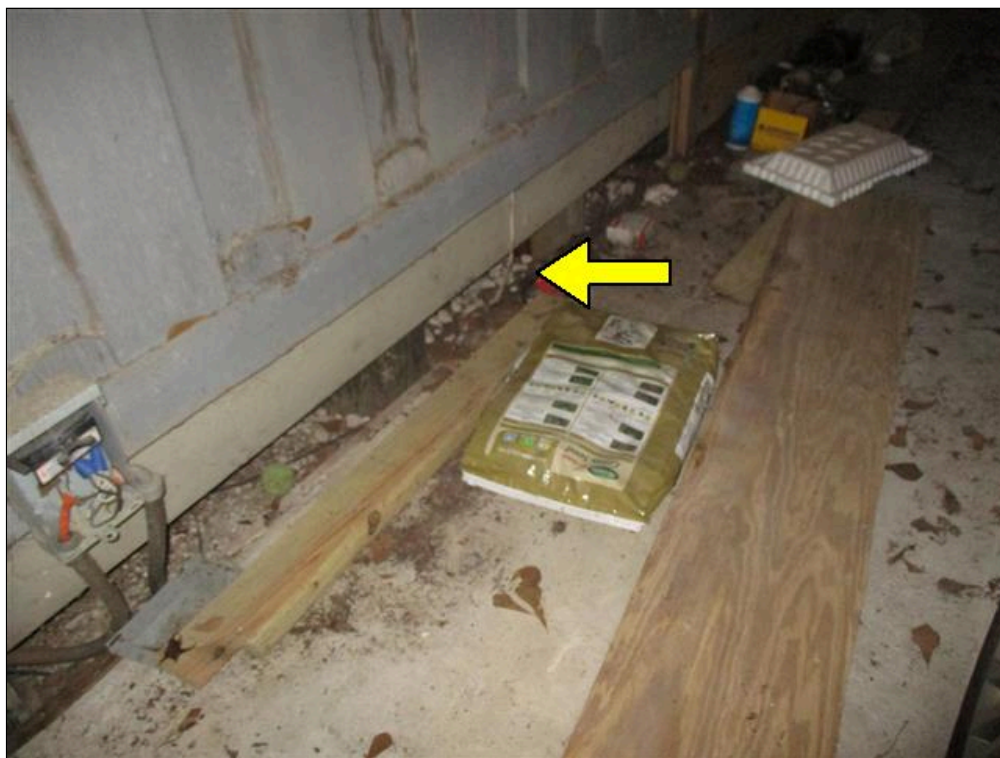
The crawlspace access is poor. Most of the crawlspace is not accessible (especially under the living room/ kitchen areas of the home).

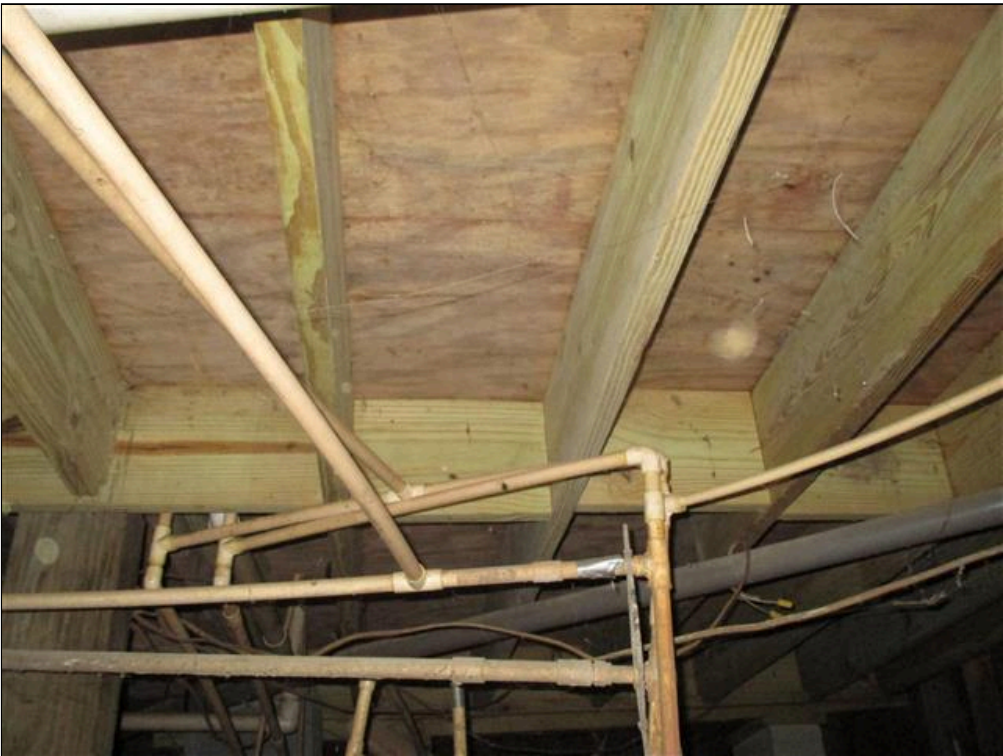
(1) Floor system is not insulated. Heat loss can occur more on this home than one that is properly insulated.

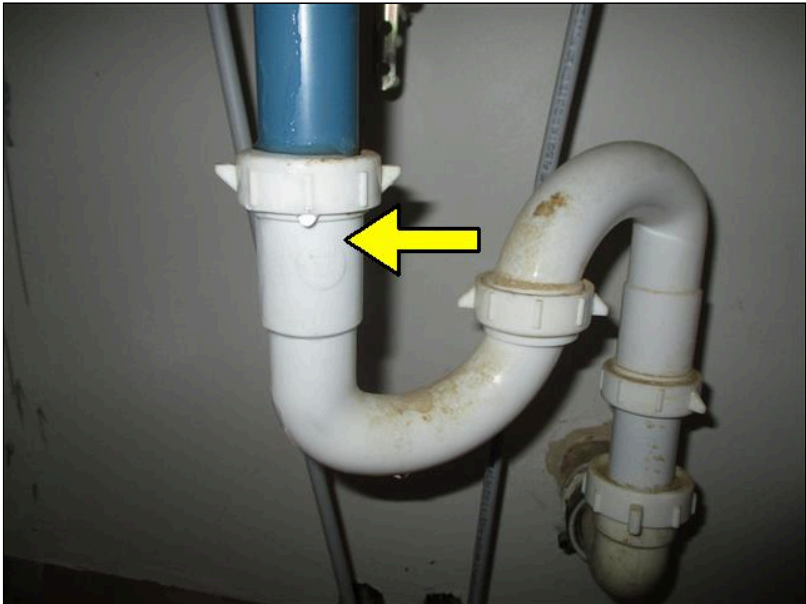
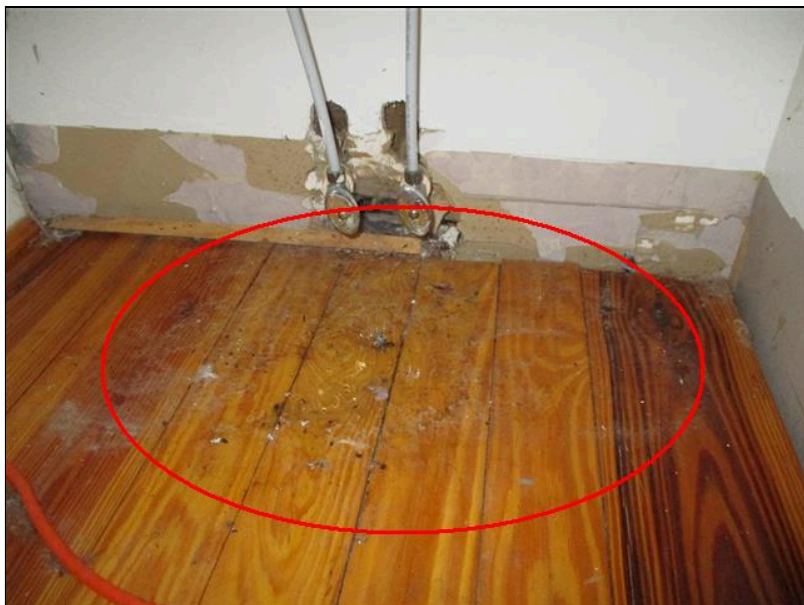
(1) There is an active drain line leak at the upstairs bathroom sink. (Hallway sink). Recommend a plumber repair.

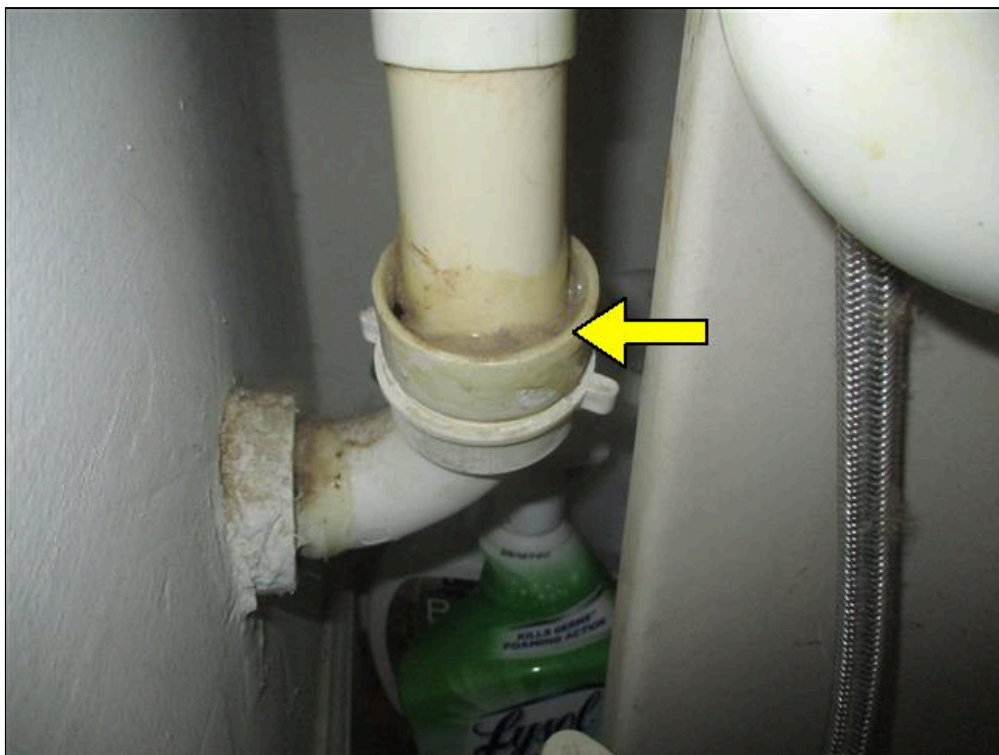
(5) The drain line at the sink at upstairs bathroom was improperly installed. (The drain line was heavily caulked) The overall quality of work appears amateur. Recommend a plumber make needed repairs.

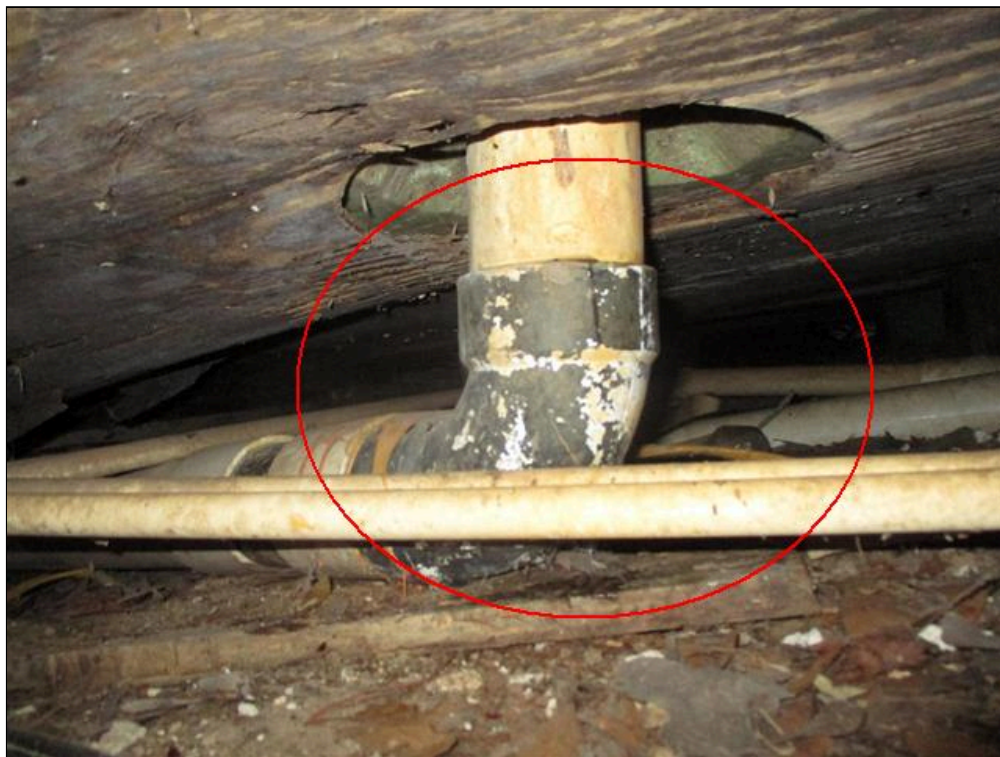
- 🏠 (7) There was an active drain line leak under the 1/2 bathroom downstairs. Recommend a plumber make needed repairs.

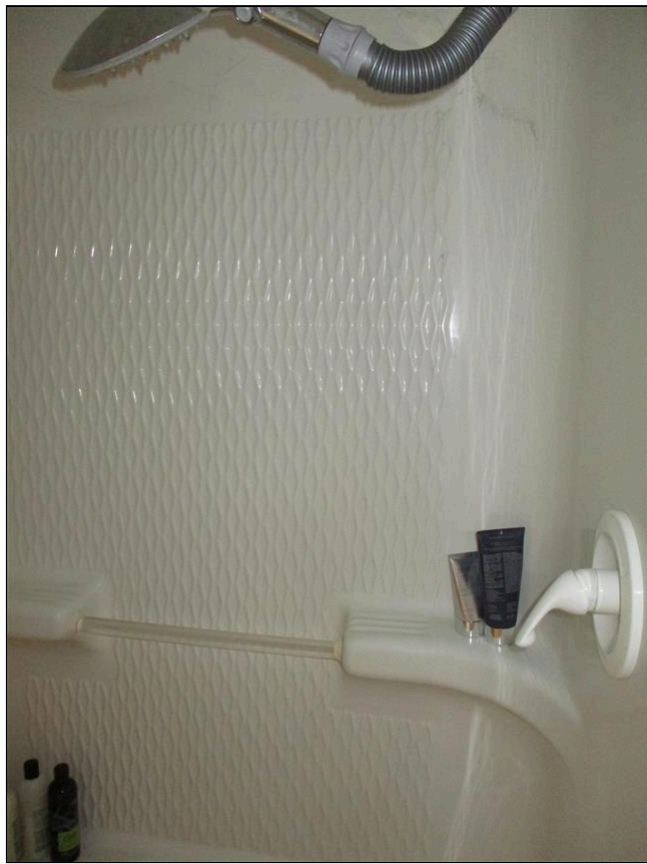
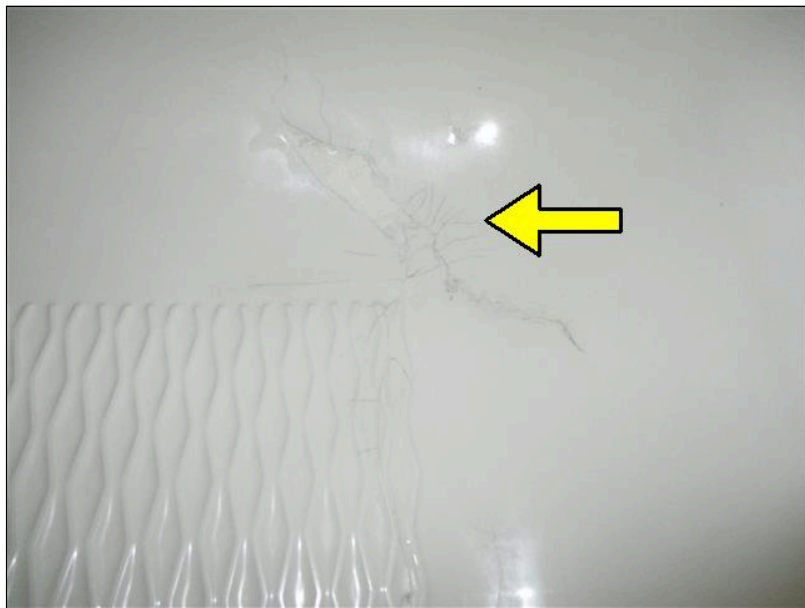
- 🏠 (1) The upstairs bathroom shower is heavily cracked and failing in areas. The shower may need replaced to prevent possible water seepage or failure. Recommend a licensed plumber make all needed repairs and/or replacements.

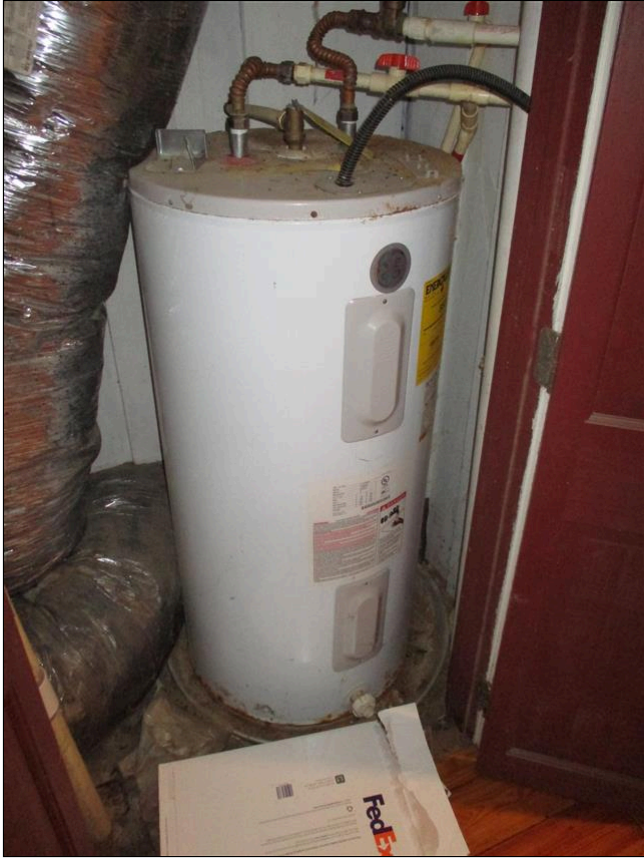
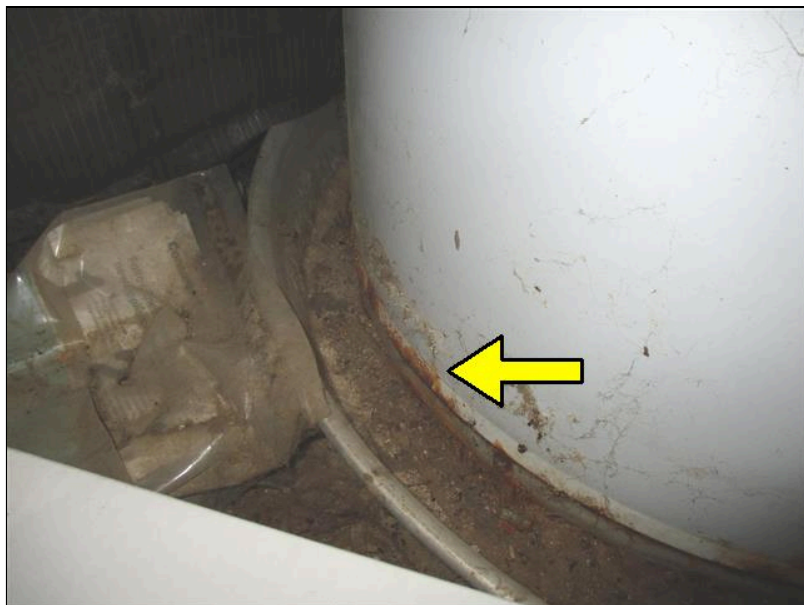
- 🏠 (1) The water heater was operational at time of inspection. However, the bottom of the unit was heavily rusted. It appears the water heater was manufactured in 2012. Typical water heaters last around 10 years. The water heater may need replaced now.

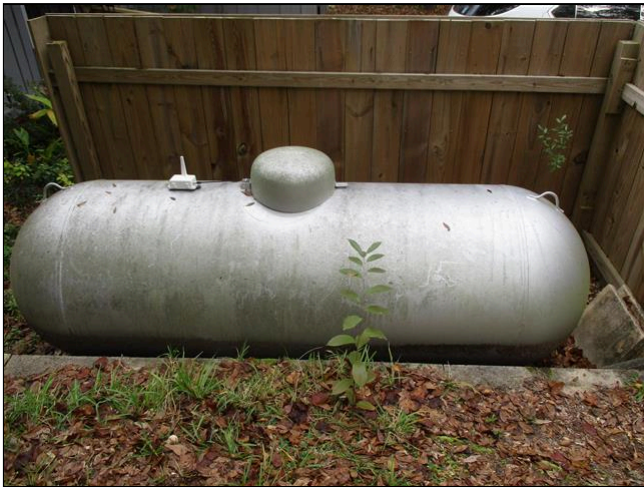
The home has a 500 gallon propane tank and a 120 gallon propane tank installed. The fuel tanks were 80% and 85% full. There were no obvious signs of fuel leaks at time of inspection.

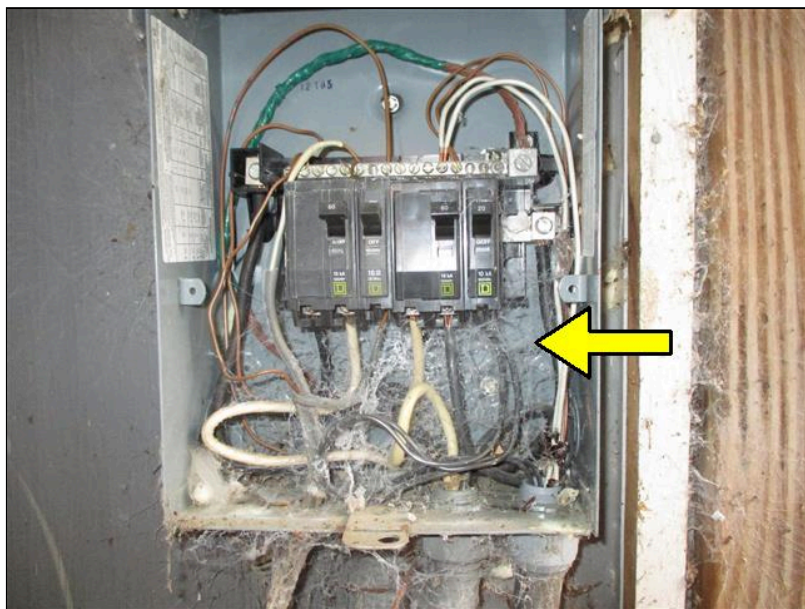
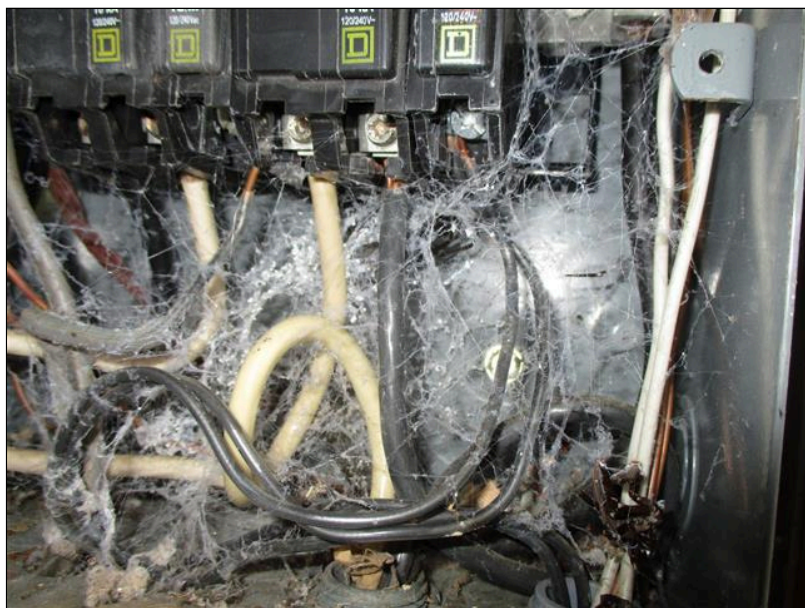
(1) Problem(s) discovered in outside 125 amp electric service panel near the dining room entry door such as **Doubled wiring at circuit(s), labels are missing or confusing, there were a lot of bugs and nests inside panel**, and any other problems that an electrician may discover while performing repairs should be corrected. Recommend a licensed electrician inspect further and correct as needed.

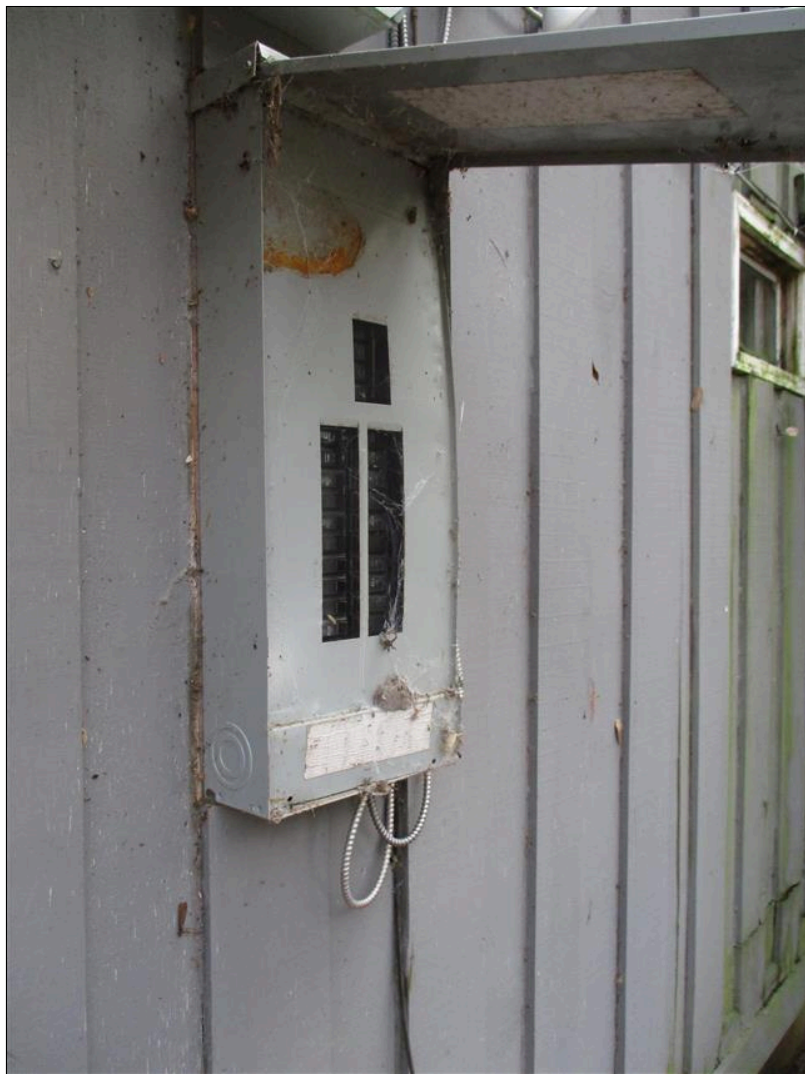
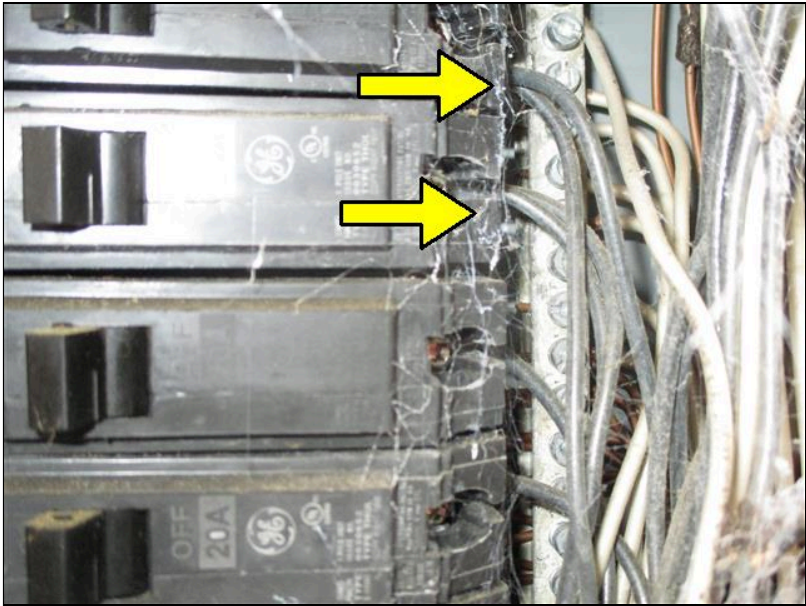
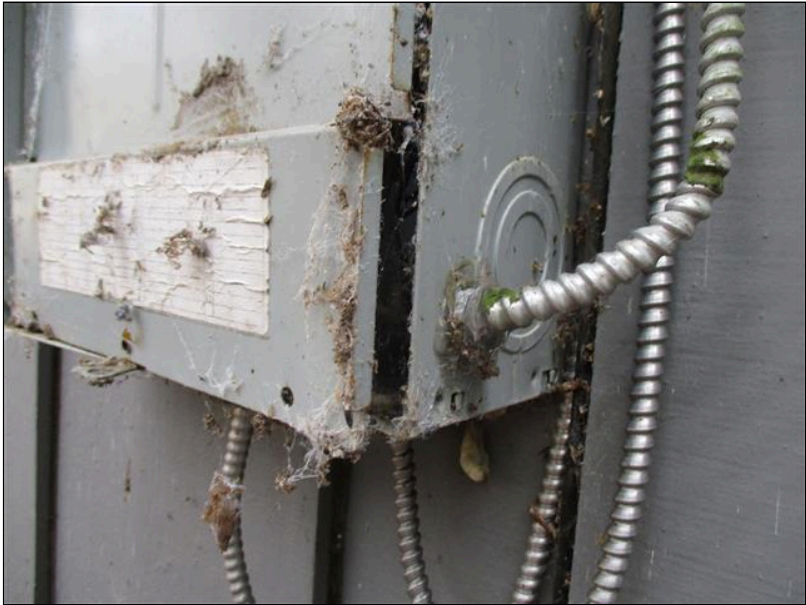
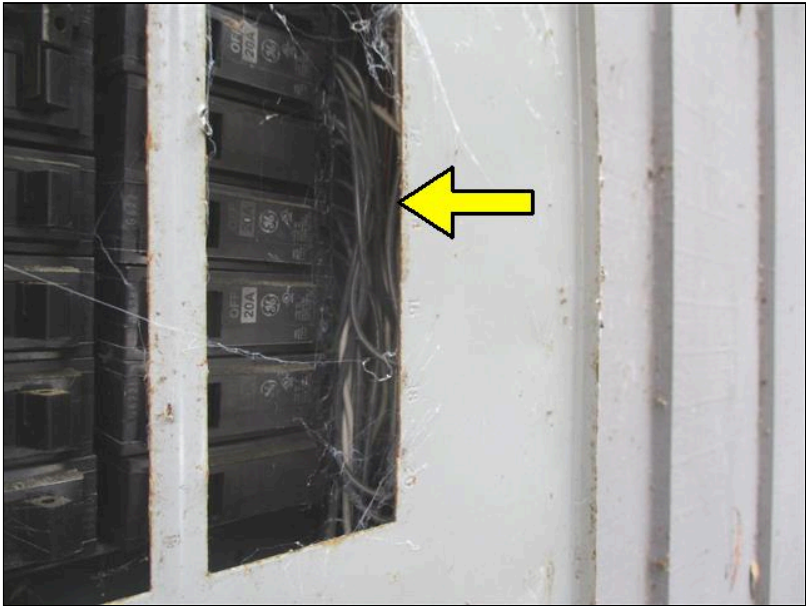
Recommend an electrician inspect further and make all needed repairs.

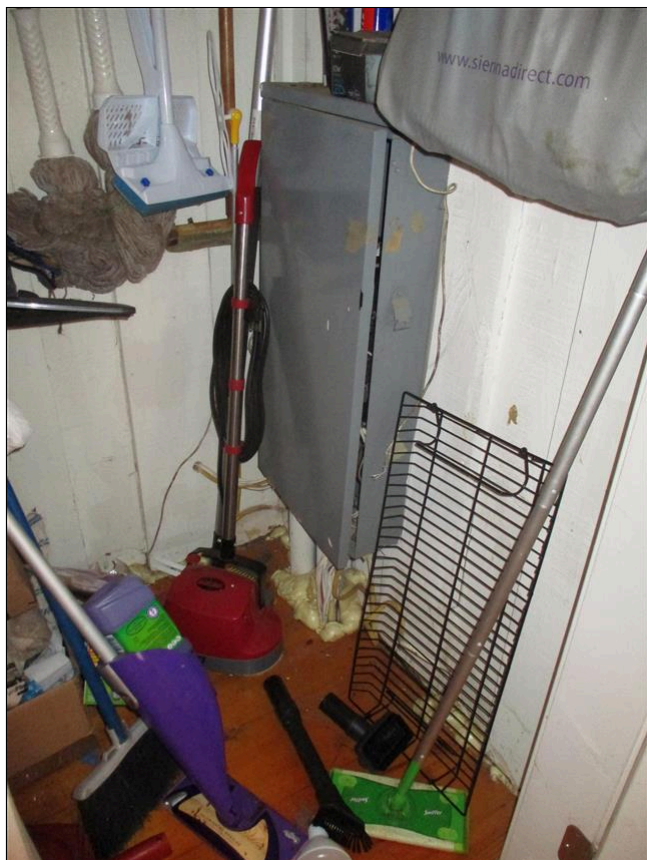
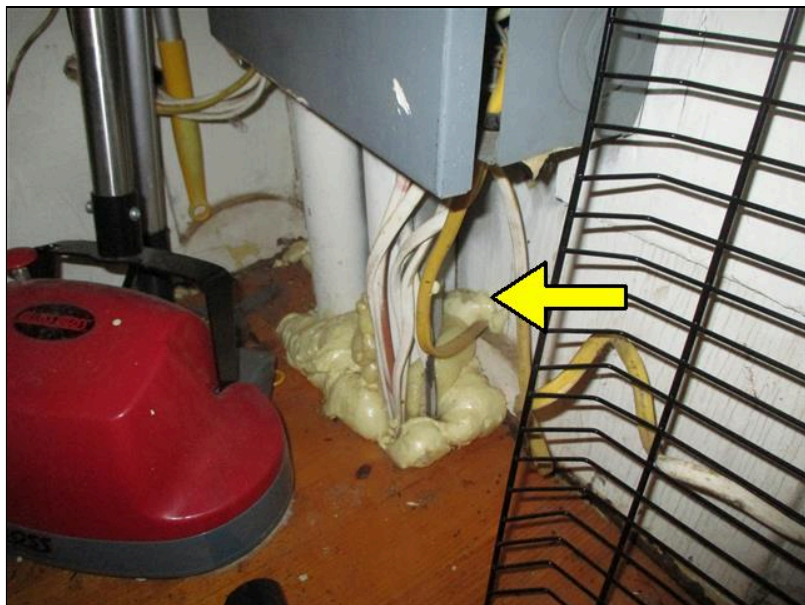
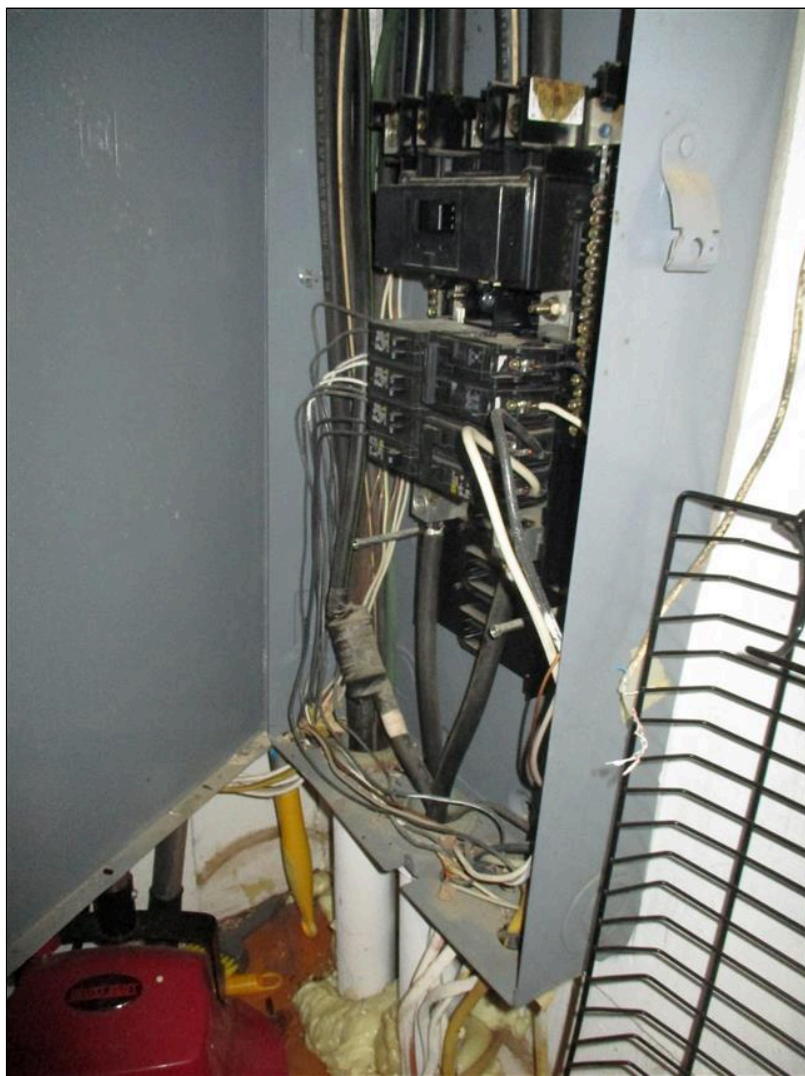
- 🏠 (3) The circuits in the electric distribution panel near the electric meter were no labeled at time of inspection. Recommend repair.
- 🏠 (4) The circuits at the 125 amp electric distribution panel in the laundry room were not labeled or identified and the electric panel had poor access. Recommend repair.
- 🏠 (5) The following defects were visible at the 200 amp electric distribution panel in the kitchen pantry:
 - the location was poor (it was too low for safety)
 - it had inadequate access
 - the dead front cover was missing leaving all the contacts exposed
 - the circuits were not labeled or identified
 - there were exposed wires below the panel

Recommend a licensed electrician inspect further and make all needed repairs now for safety.

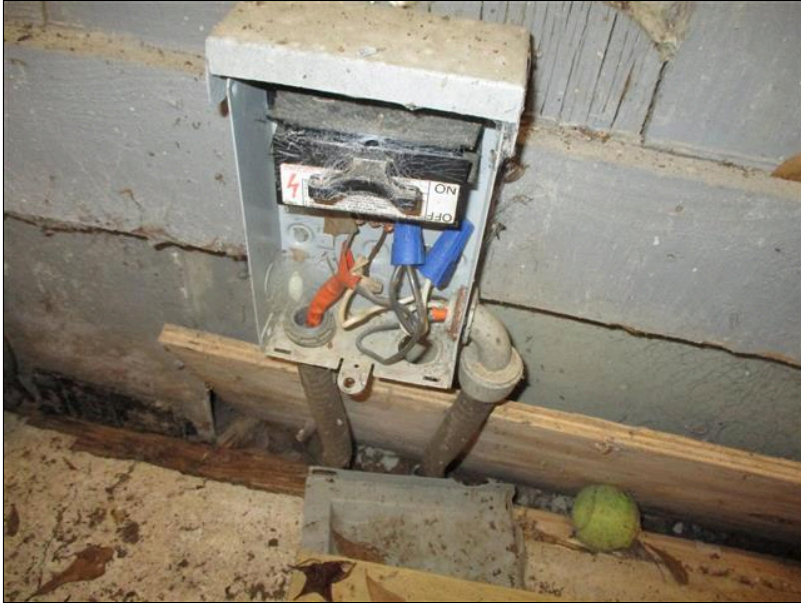
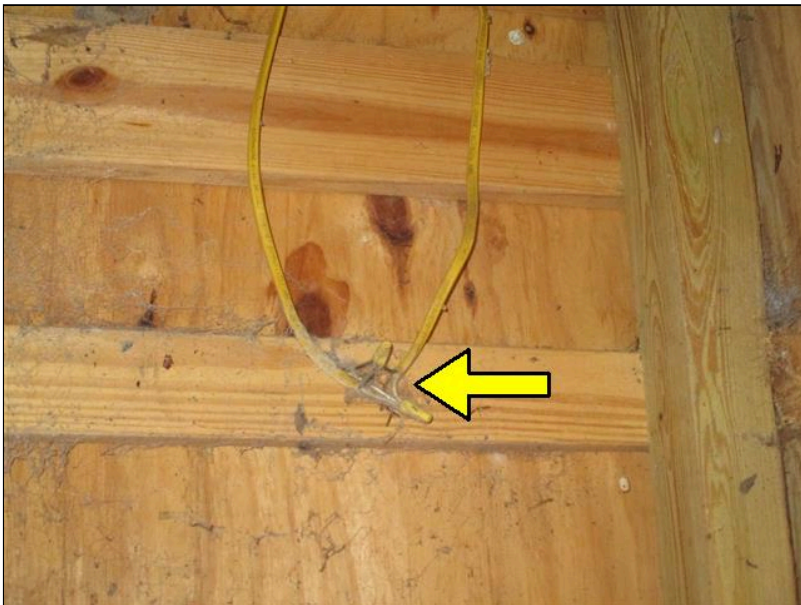
🏠 (4) There are multiple exposed wires visible in the garage. Recommend an electrician repair for safety.

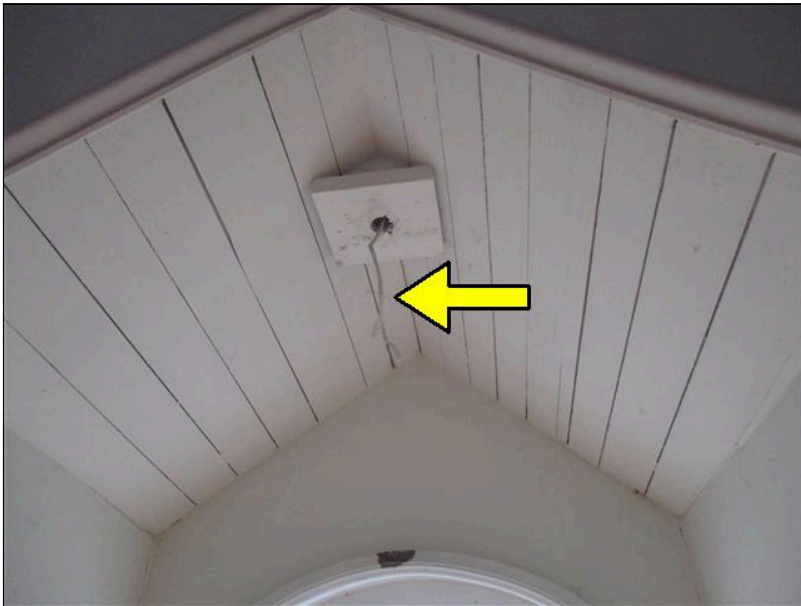
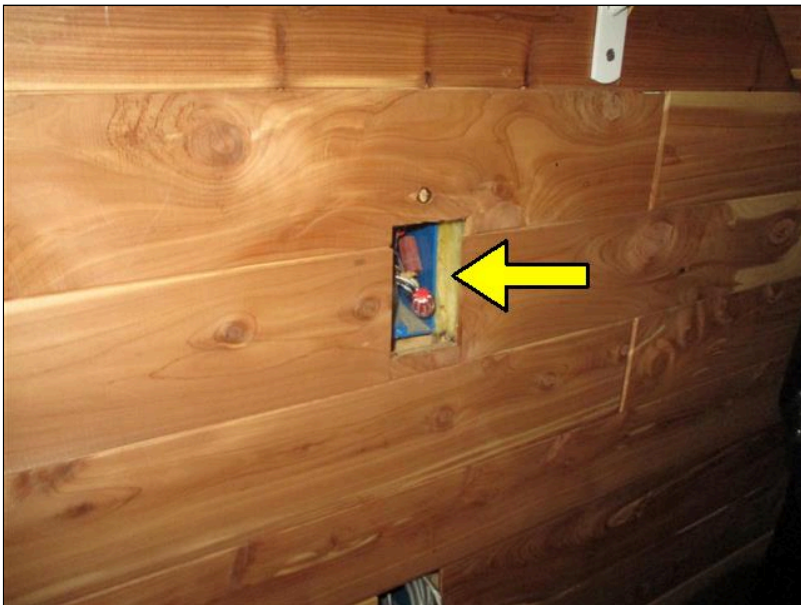
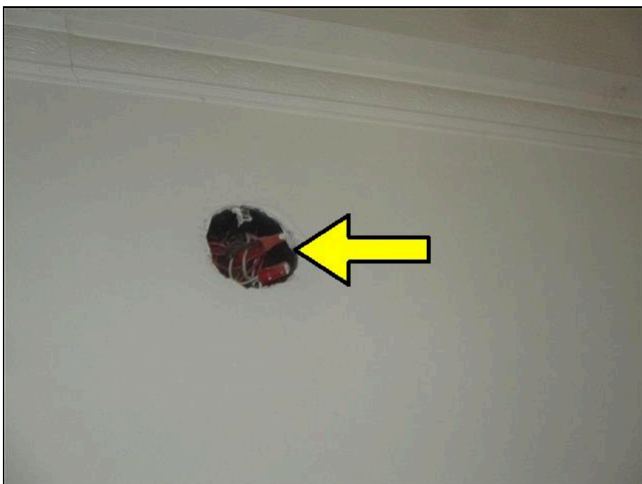
(5) There are multiple exposed and abandoned wires at the upstairs bedroom. Recommend an electrician make needed repairs for safety.
