Inspection Report

455 Crow Hill Dr.
Georgetown SC 29440

Buckeye Home Inspections

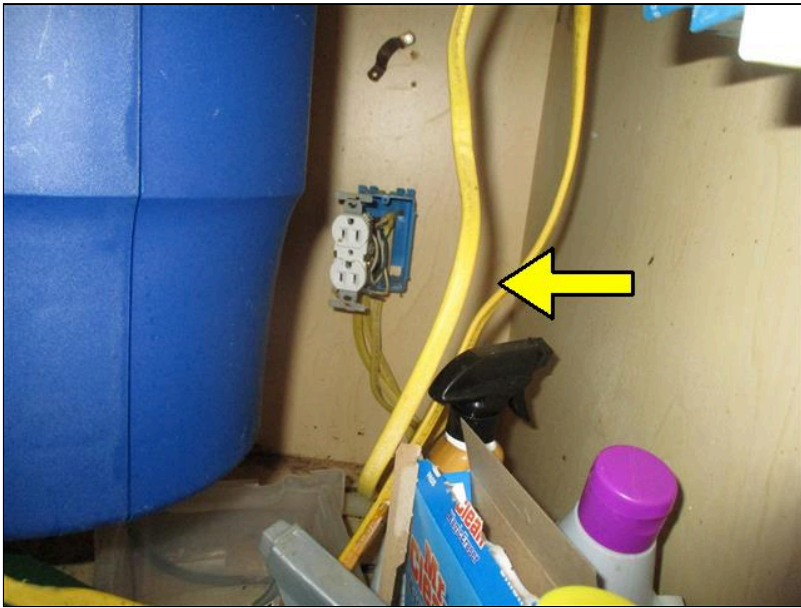
- 🏠 (6) There were multiple exposed wires and a loose electric receptacle under the kitchen sink. Recommend an electrician repair.

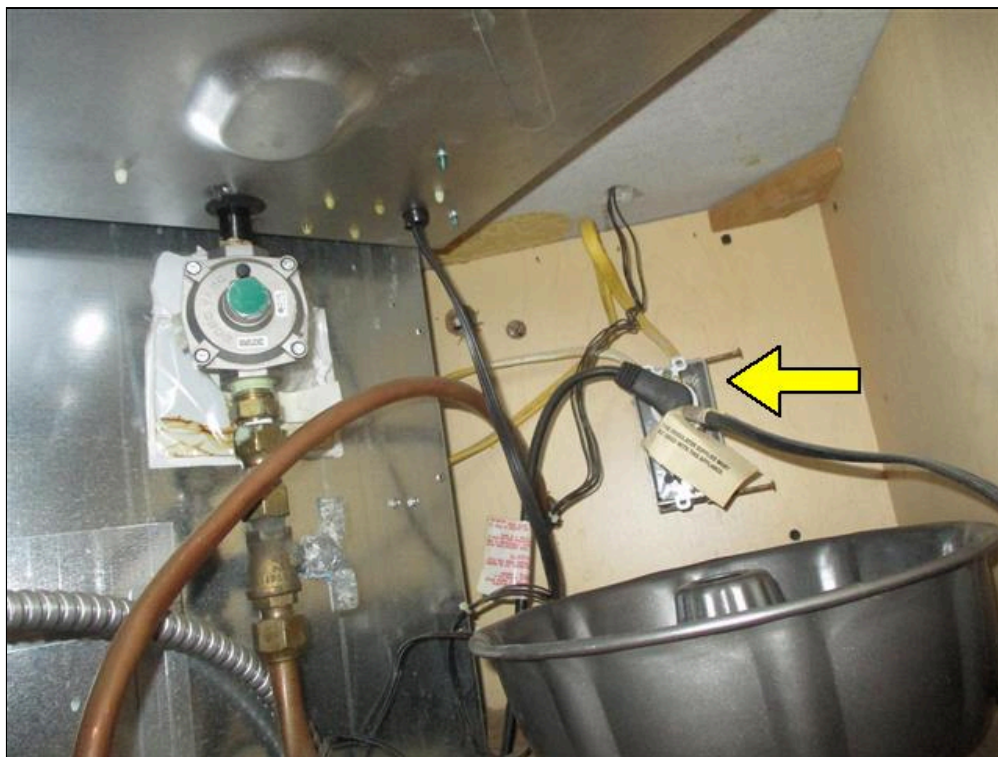
- 🏠 (7) There are exposed wires under the gas cooktop in kitchen. Recommend an electrician repair.

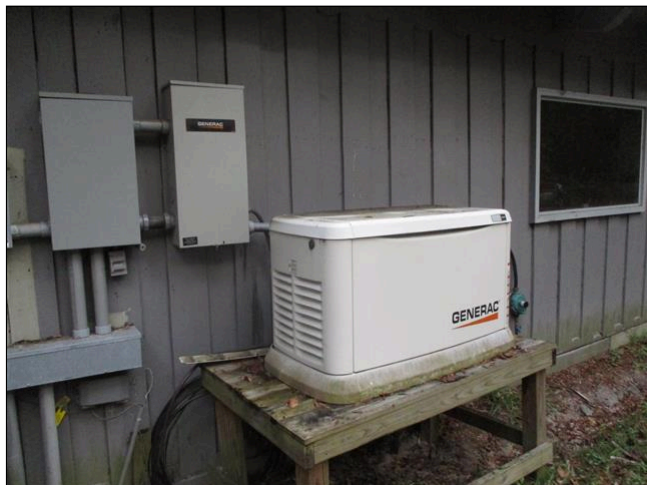
The home has a gas powered generator installed. The inspection of generators is outside the scope of a home inspection. Therefore, the generator was not evaluated during this inspection.

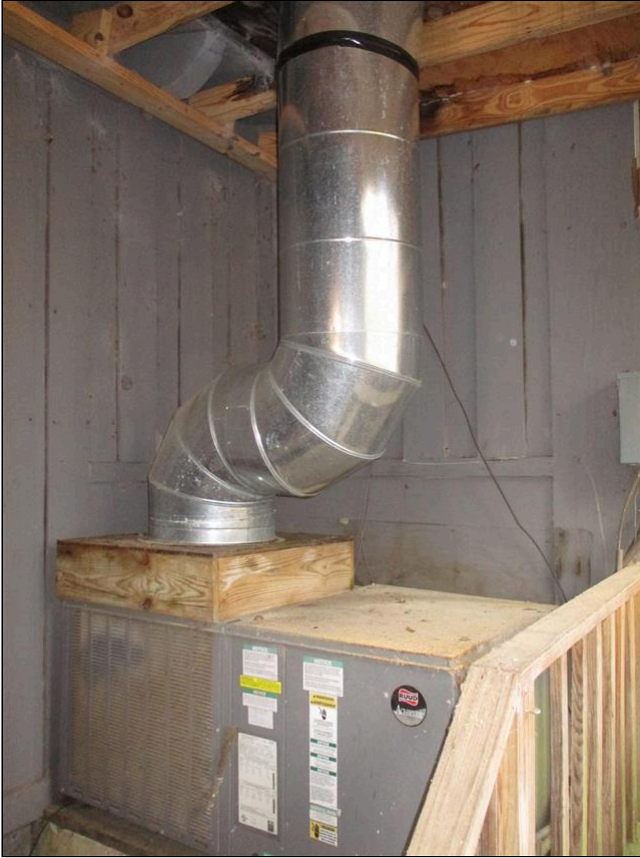
(1) The package heat pump was operational at time of inspection. However, the unit did not reveal signs of recent maintenance or service. Heat pumps should be serviced 2 times a year by a licensed HVAC technician. Recommend an HVAC technician service the unit now.

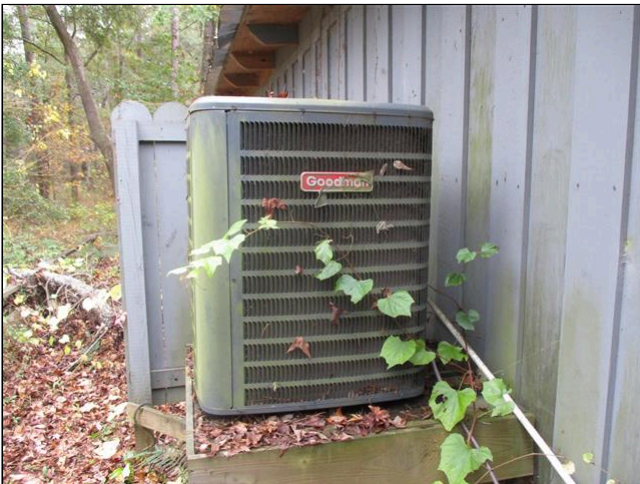
(3) The 2 ton heat pump was operational. There were no obvious signs of major defects at time of inspection. Heat pumps should be serviced 2 times a year by a licensed HVAC technician. Recommend a licensed HVAC technician service the heat pump now.

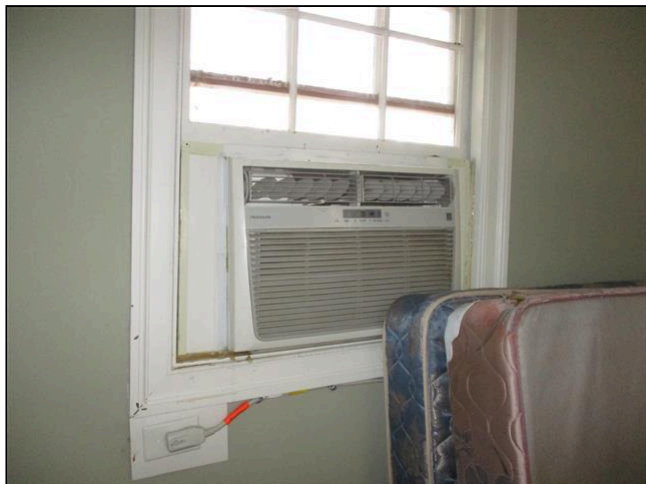
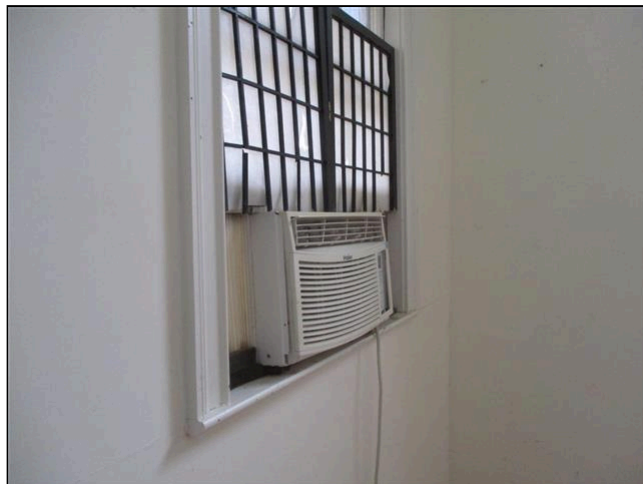
(4) There are several window unit air conditioners/heaters installed upstairs. The inspection of window unit air conditioners/heaters is outside the scope of a home inspection. However, the units appeared to be in poor condition.

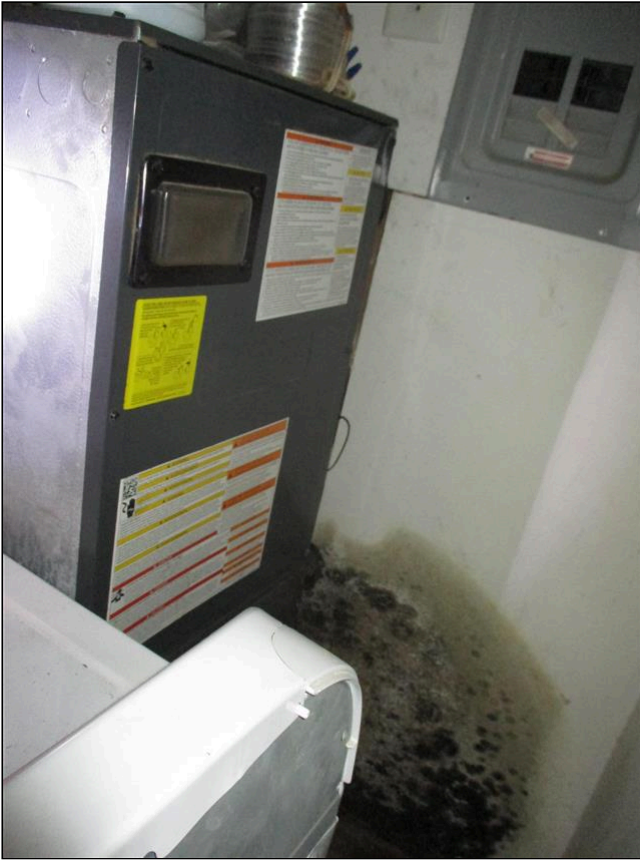
(2) The heating system in the laundry room was operational at time of inspection. However, the unit did not reveal signs of maintenance or service at time of inspection. Heating systems should be cleaned and serviced 2 times a year by a licensed HVAC technician. Recommend an HVAC technician inspect and service the heating system now.

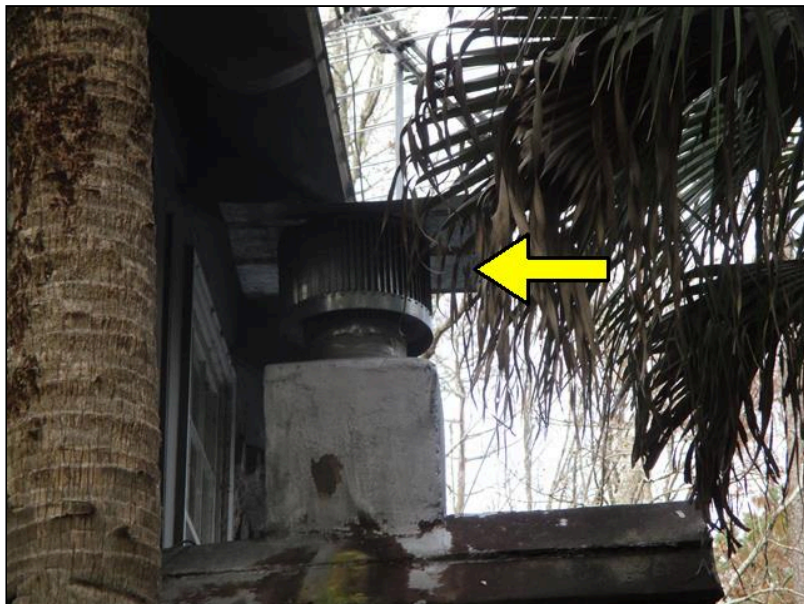
(1) The chimney for the gas fireplace in the master bedroom has inadequate clearance. The fireplace is not safe to use in its current condition. Recommend a qualified gas technician or fireplace technician inspect further and make all needed repairs.

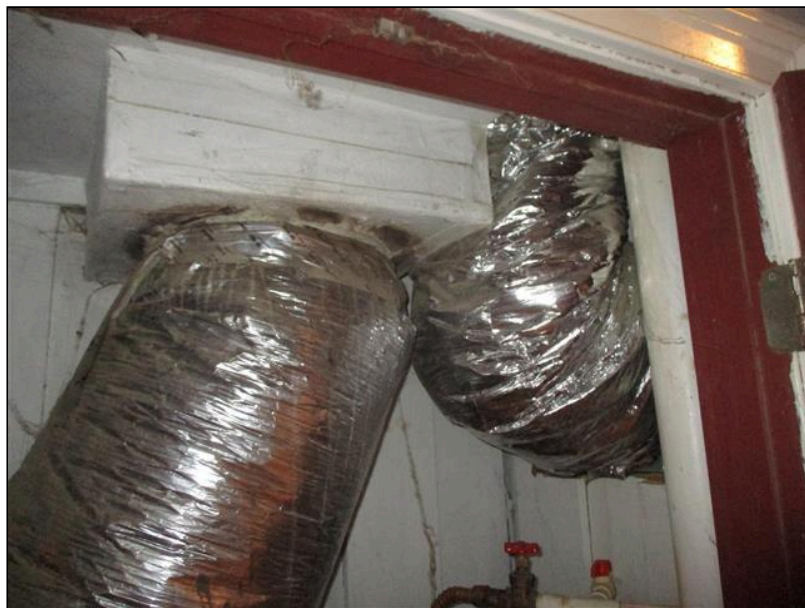
(2) The HVAC ducts are not visible. They are located in the crawlspace in areas and in the attic. There were no access to the HVAC ducts. The ducts that were visible were losing air at connections and kinked. Recommend an HVAC technician inspect further and make all further recommendations and repairs.

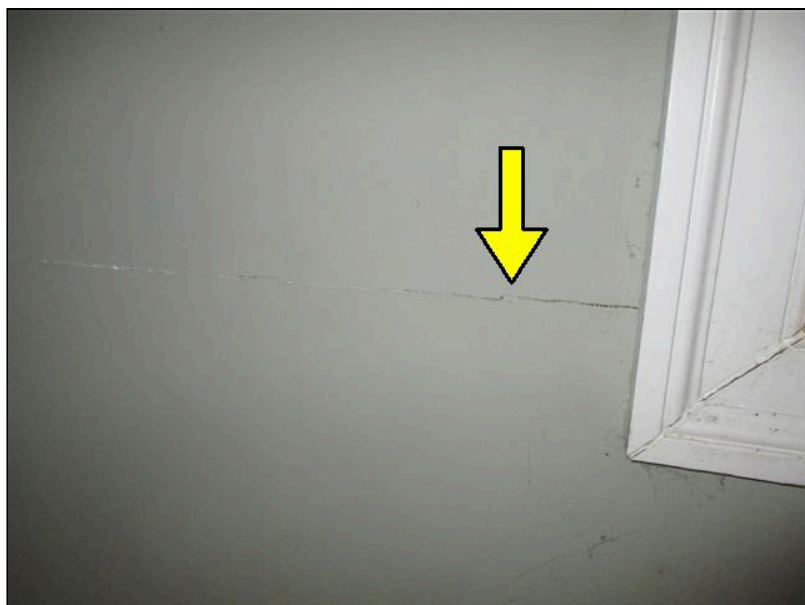
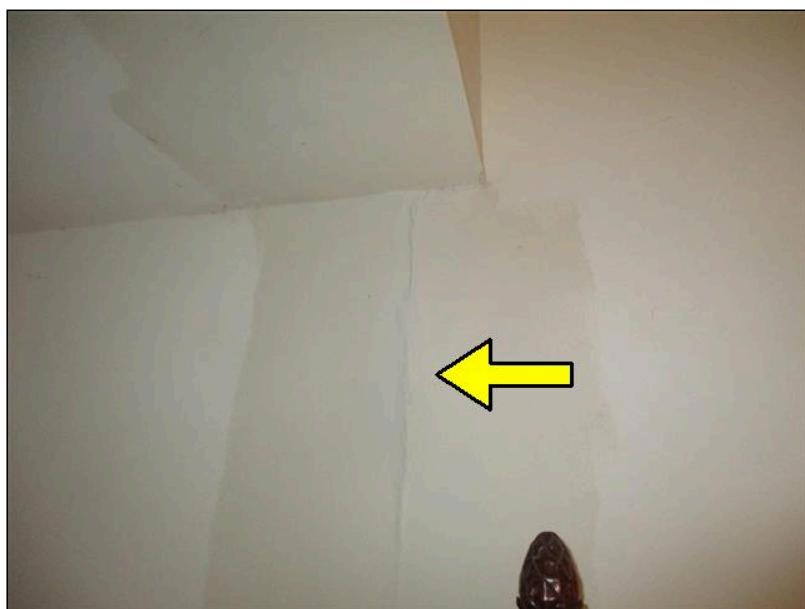
- (1) The interior walls revealed the following non-cosmetic defects at time of inspection:
- there were multiple cracks in the sheetrock at all rooms indicating structural movement
 - multiple walls were sagging or unlevel indicating structural movement

Recommend a structural engineer evaluate the home further and make all further recommendations and repairs.

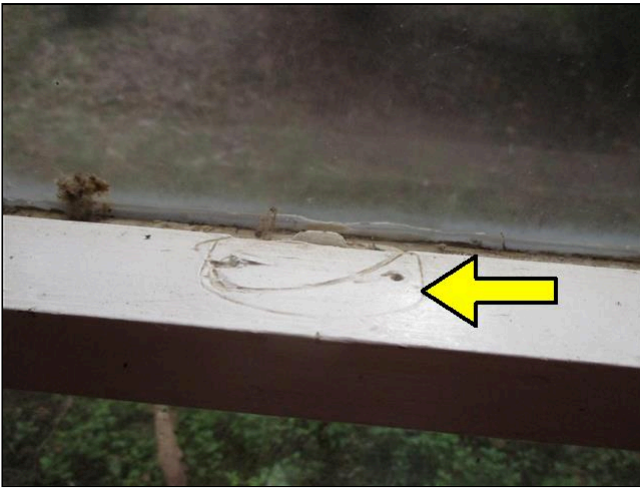
- 🏠 (1) The locks were missing at all windows. Why? Recommend repair.

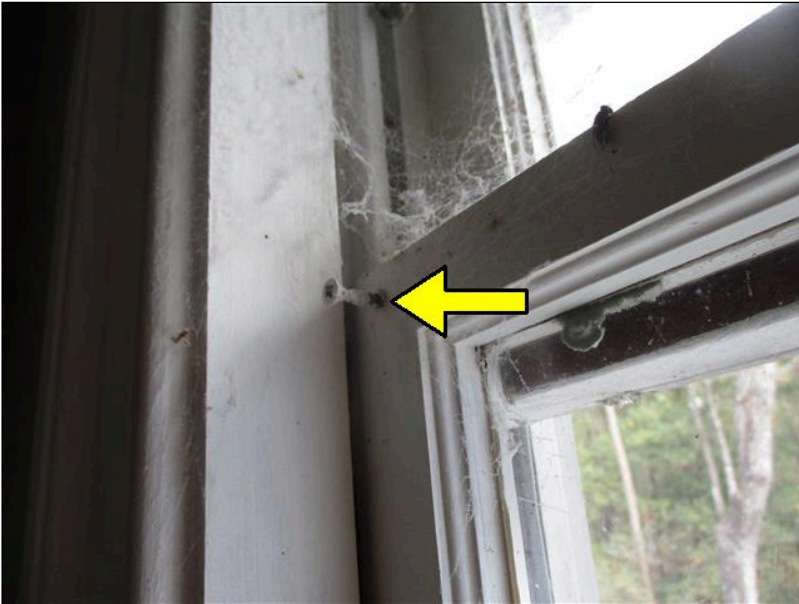
- 🏠 (3) Most if not all windows were screwed shut. One cannot open the windows without first removing the screws. This is preventing adequate egress. Recommend a qualified professional repair.

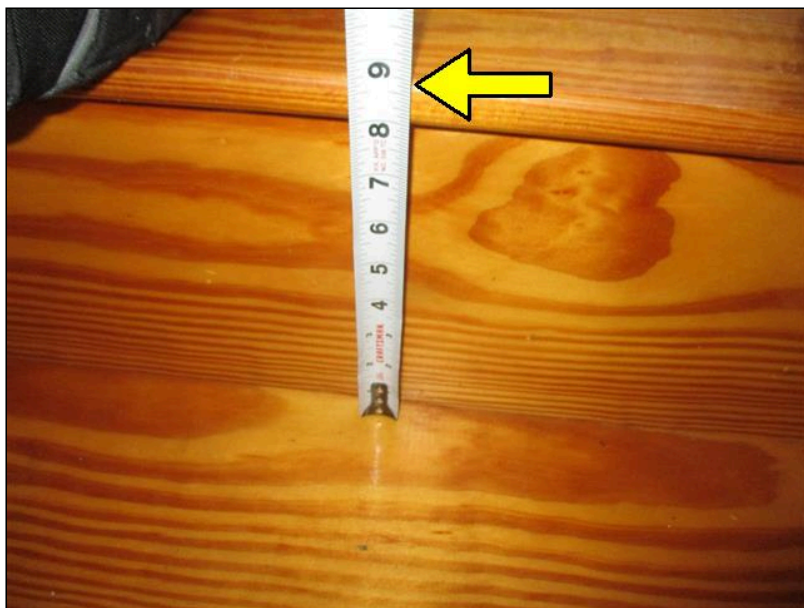
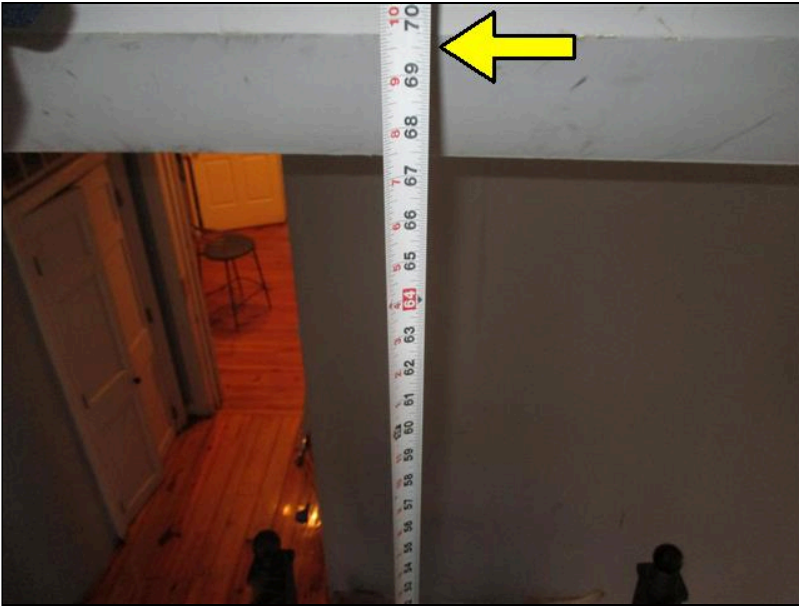
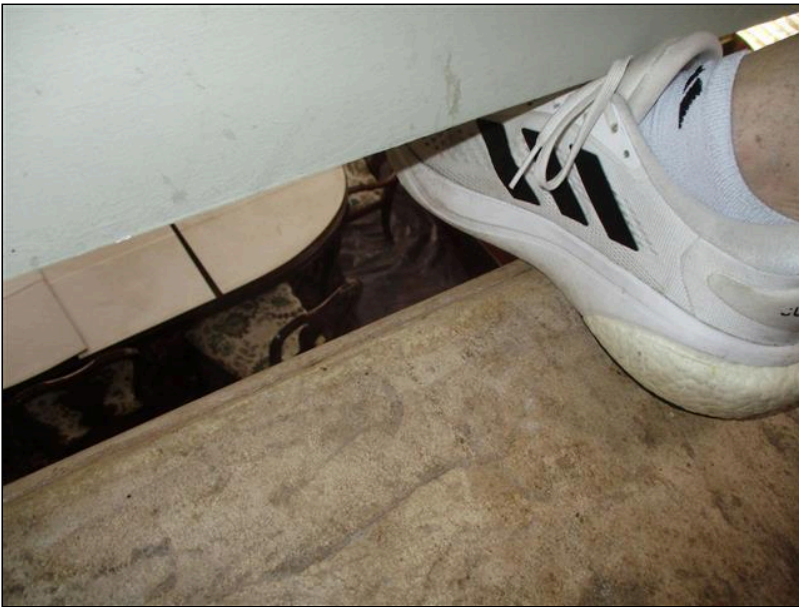
The interior staircase revealed the following defects at time of inspection:

- steps were too high for safety
- the ceiling height for staircase was too low (Stairways shall have a headroom clearance of not less than 80 inches)
- there were gaps between the staircase and the walls that could allow one to trip

Recommend a licensed contractor make all needed repairs.

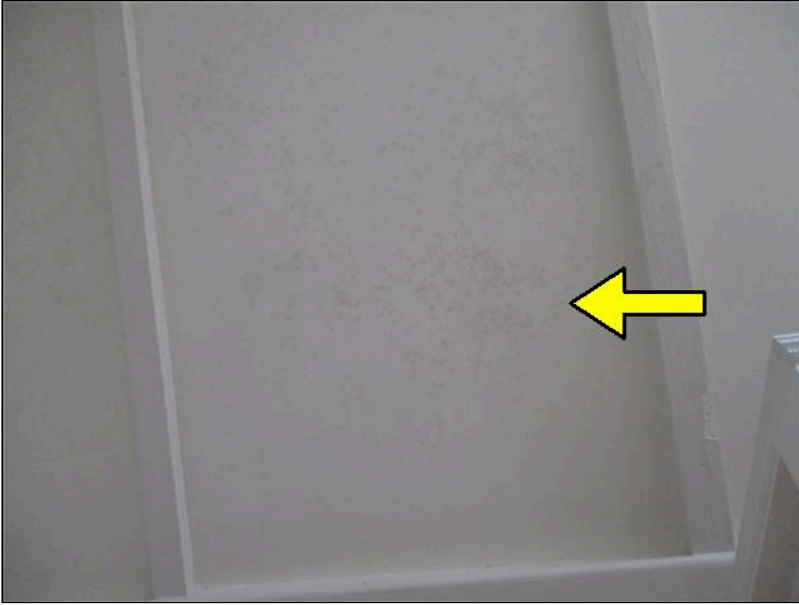
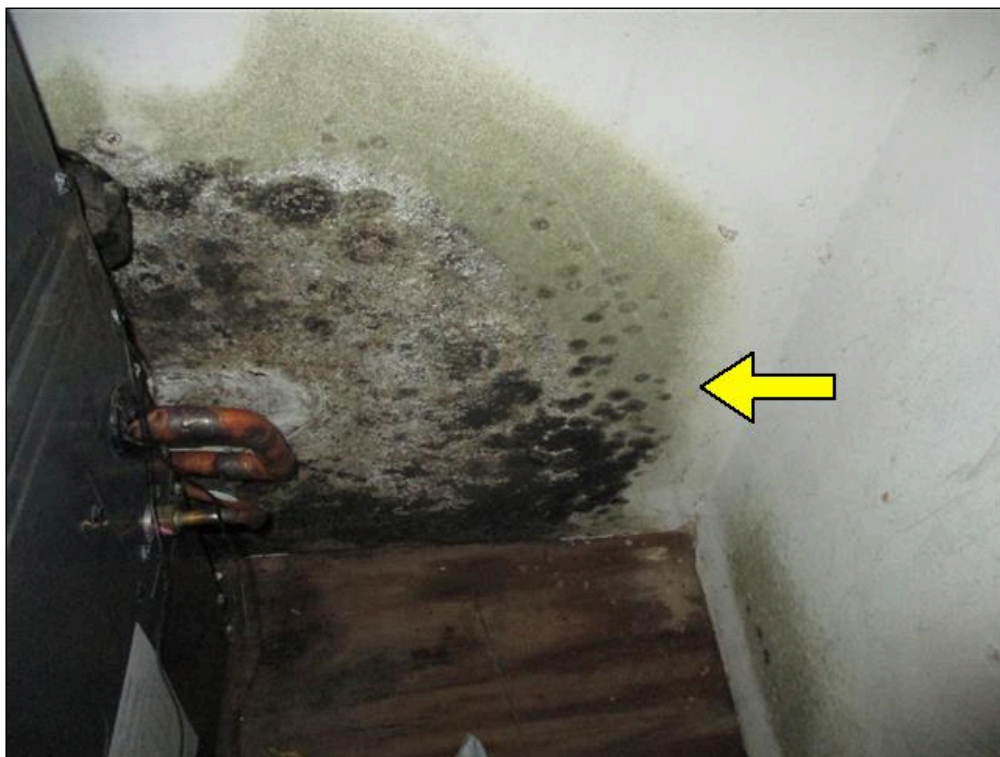
There are multiple signs of possible mold on most if not all surface of the home. I did not test to determine if the possible mold was toxic or a health hazard. Recommend a qualified mold cleaning professional inspect further and make all needed repairs.

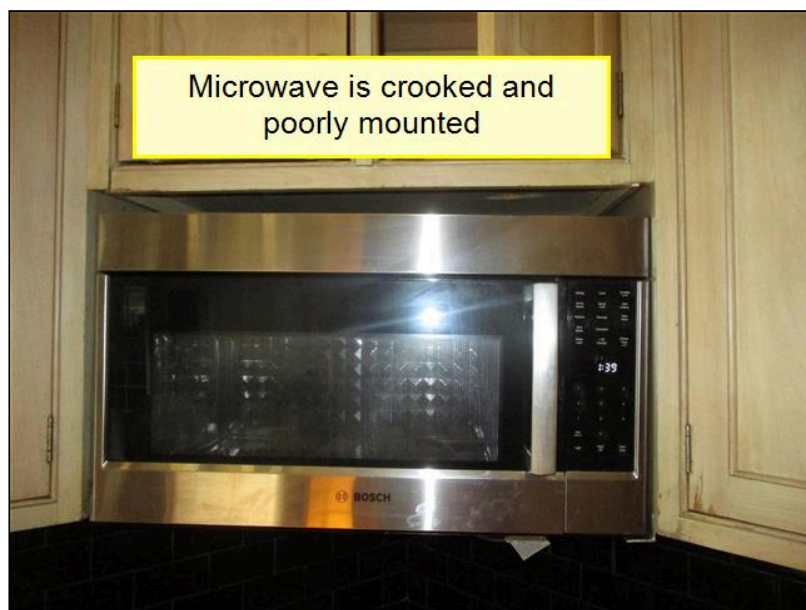
The microwave was operational. However, the unit was poorly installed. It was crooked and appeared to be poorly mounted. Recommend repair or replace.

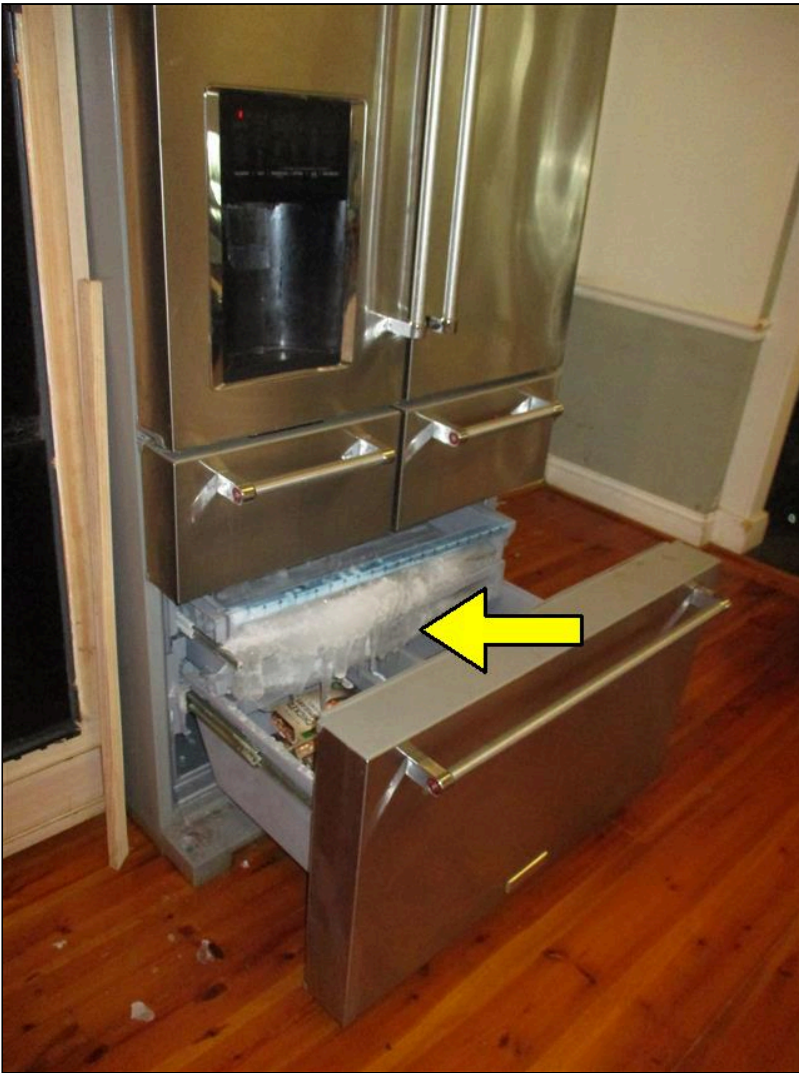
The freezer was full of ice indicating the defrost cycle was not working. Recommend a qualified professional repair or replace.
